# Structural Assessment Report

## **365 Princes Highway, Officer VIC 3809 Prepared for Timbertop East Pty Ltd**

| Report Date: | 19/11/2021 |
| Date of Inspection: | 26/10/2021 |

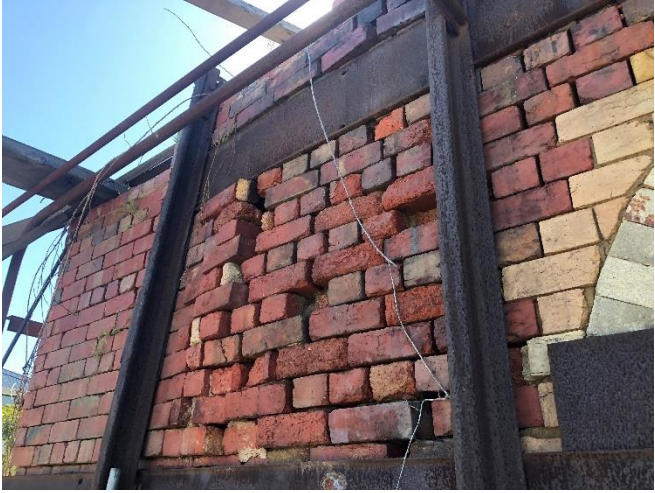
Various points on the external brickwork appear to be bulging outwards, resulting in displacement and separation. This is likely attributed to the horizontal outward (thrust) forces that result from the arch style of structure. As the structure has aged and lost strength (possibly related to erosion of mortar) it has no longer had the capacity to resist its own self weight in this structural configuration. Further failure of structure appears to have been avoided through the use of steel framing around kiln. This is only applicable to the kiln structure.

| Photographs | Observation |
|---|---|
| | <p>Photograph 5</p> <hr/> <p><b>Observation:</b> Brick wall bulging. Brick displacement and separation Eroded mortar.</p> <p><b>Location:</b> Front (west) elevation.</p> |

Kiln structure will require repointing of mortar with similar/appropriate lime based mortar. Displaced, damaged or bulging sections of brickwork will require deconstruction and re bricking. Section where mortar completely eroded or compromised will require reconstruction. A suitably qualified and experienced tradesperson should be engaged to undertake works.

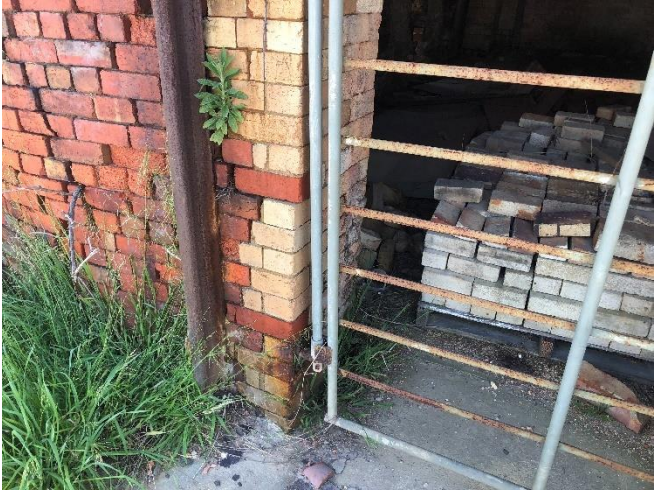
| Photographs | Observation |
|---|---|
| | <p>Photograph 6</p> <hr/> <p><b>Observation:</b> Stepped brickwork cracking.</p> <p><b>Location:</b> Front (west) elevation.</p> |

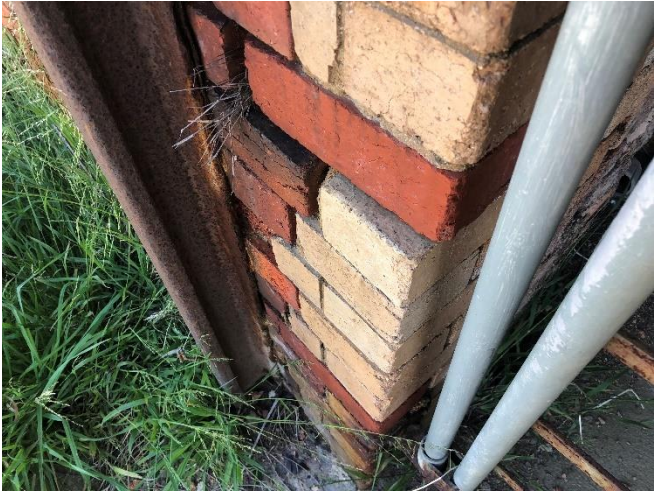
| Photographs | Observation |
|---|---|
| | <p>Photograph 7</p> <hr/> <p><b>Observation:</b> Brick displacement.</p> <p><b>Location:</b> Front (west) elevation.</p> |

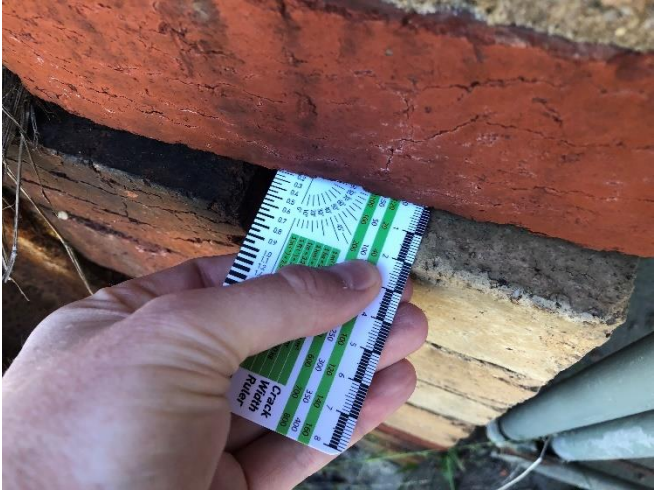
| Photographs | Observation |
|---|---|
| | <p>Photograph 8</p> <hr/> <p><b>Observation:</b> Brick displacement.</p> <p><b>Location:</b> Front (west) elevation.</p> |

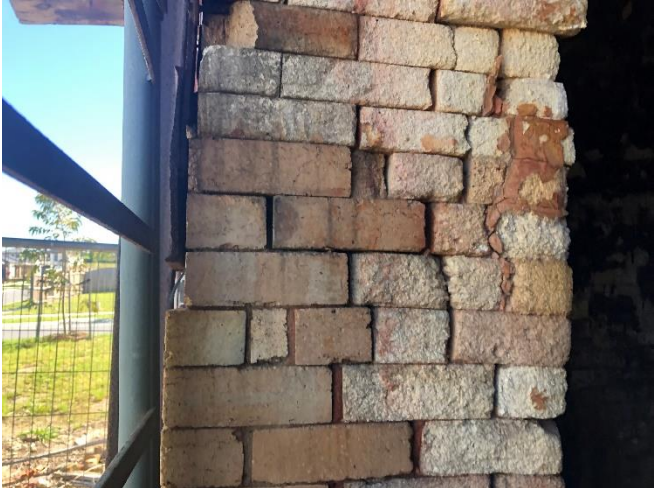
| Photographs | Observation |
|---|---|
| | <p>Photograph 9</p> <hr/> <p><b>Observation:</b> Brick cracking. Mortar and brickwork erosion.</p> <p><b>Location:</b> Front entrance west elevation.</p> |

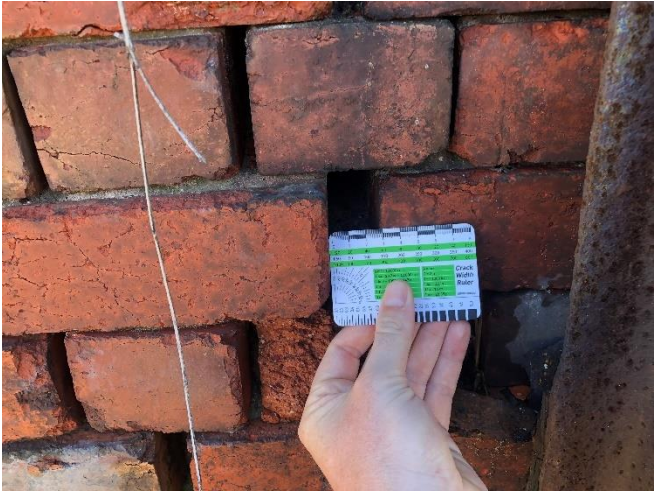
| Photographs | Observation |
|---|---|
| | <p>Photograph 10</p> <hr/> <p><b>Observation:</b> Brick separation. Mortar erosion.</p> <p><b>Location:</b> Front (west) elevation.</p> |

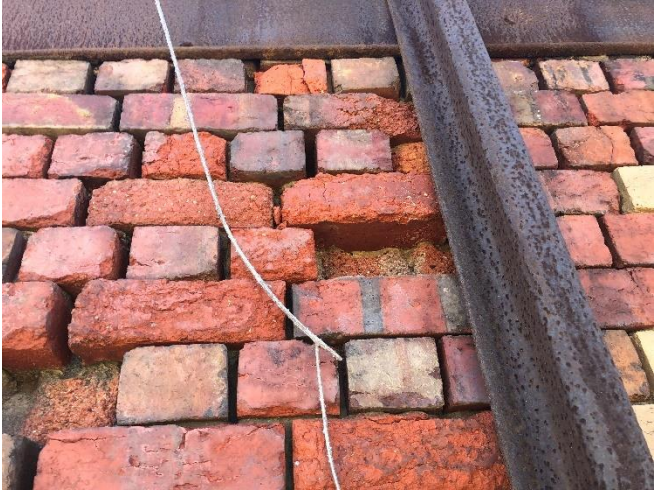
| Photographs | Observation |
|---|---|
| | <p>Photograph 11</p> <hr/> <p><b>Observation:</b> Missing Bricks. Mortar erosion.</p> <p><b>Location:</b> Front (west) elevation.</p> |

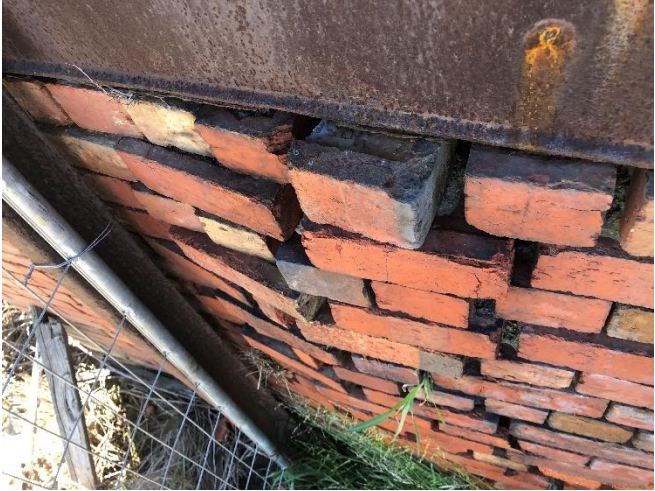
| Photographs | Observation |
|---|---|
| | <p>Photograph 12</p> <hr/> <p><b>Observation:</b> Brick wall bulging. Brick displacement and separation. Mortar erosion.</p> <p><b>Location:</b> Front (west) elevation.</p> |

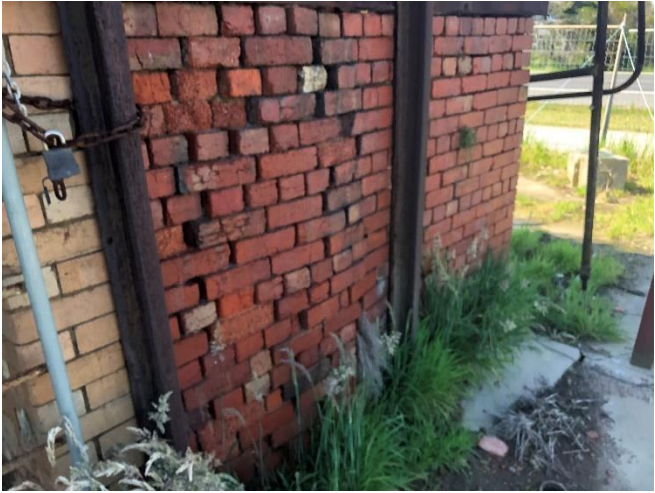
| Photographs | Observation |
|---|---|
| | <p>Photograph 13</p> <hr/> <p><b>Observation:</b> Brick displacement and separation. Mortar erosion.</p> <p><b>Location:</b> Front (west) elevation.</p> |

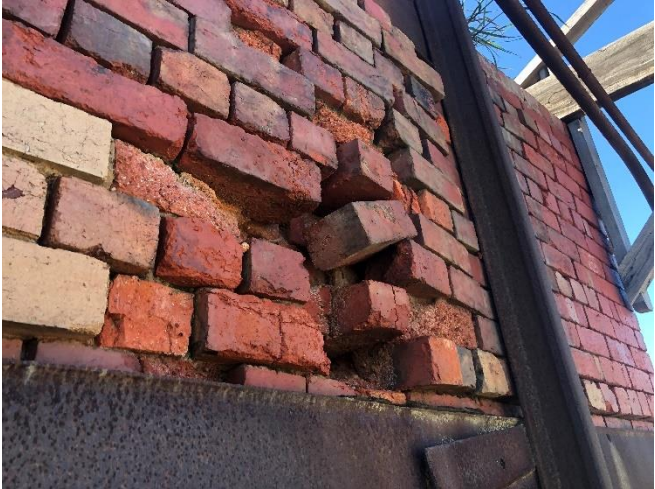
| Photographs | Observation |
|---|---|
| | <p>Photograph 14</p> <hr/> <p><b>Observation:</b> Brick displacement and separation. Mortar erosion.</p> <p><b>Location:</b> Side (south) elevation.</p> |

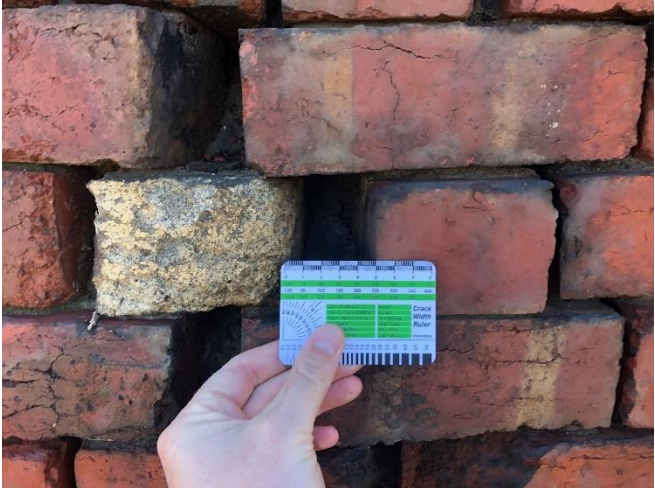
| Photographs | Observation |
|---|---|
| | <p>Photograph 15</p> <hr/> <p><b>Observation:</b> Brick displacement and separation. Mortar erosion.</p> <p><b>Location:</b> Side (south) elevation.</p> |

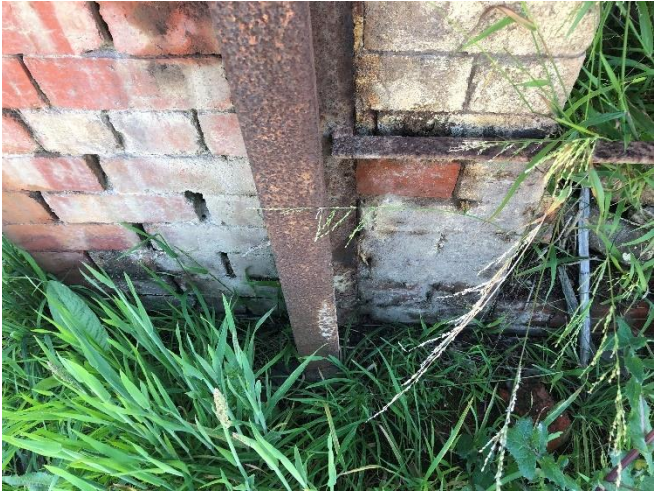
| Photographs | Observation |
|---|---|
| | <p>Photograph 16</p> <hr/> <p><b>Observation:</b> Evidence of moisture ingress to brickwork.</p> <p><b>Location:</b> Side (south) elevation.</p> |

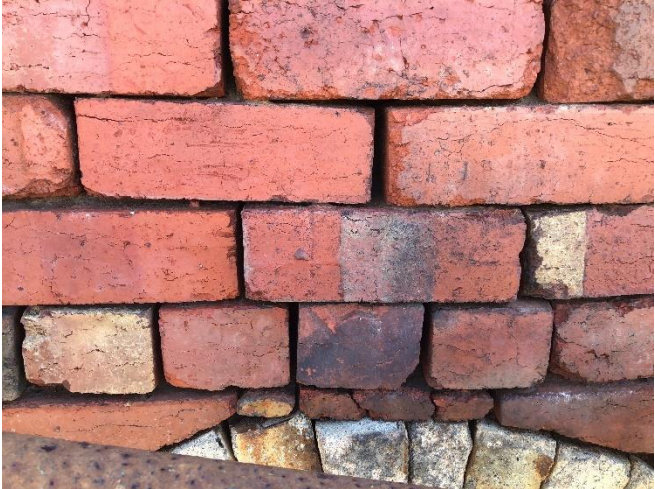
| Photographs | Observation |
|---|---|
| | <p>Photograph 17</p> <hr/> <p><b>Observation:</b> Mortar erosion.</p> <p><b>Location:</b> Side (south) elevation.</p> |

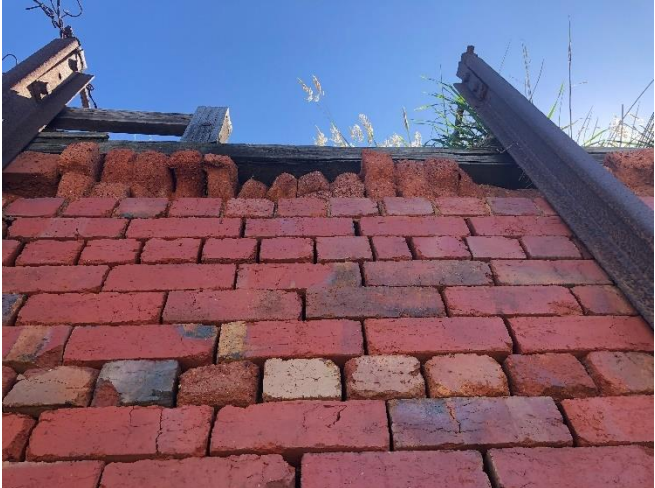
| Photographs | Observation |
|---|---|
| | <p>Photograph 18</p> <hr/> <p><b>Observation:</b> Mortar and brickwork erosion.</p> <p><b>Location:</b> Side (south) elevation.</p> |

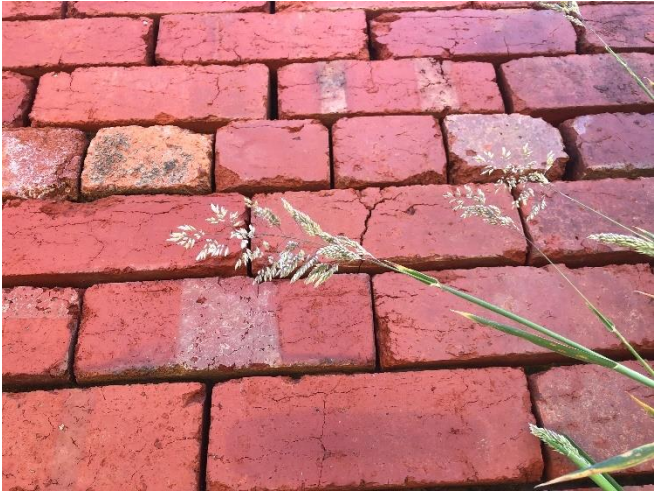
| Photographs | Observation |
|---|---|
| | <p>Photograph 19</p> <hr/> <p><b>Observation:</b> Mortar erosion and brickwork cracking.</p> <p><b>Location:</b> Side (south) elevation.</p> |

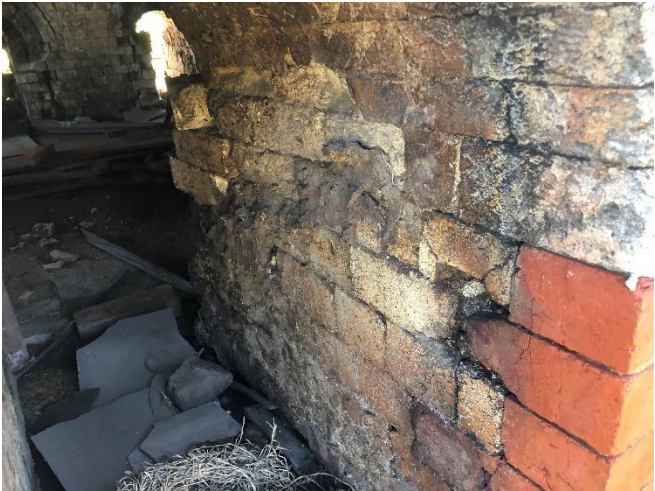
| Photographs | Observation |
|---|---|
| | <p>Photograph 20</p> <hr/> <p><b>Observation:</b> Build-up in archway.</p> <p><b>Location:</b> Side (south) elevation.</p> |

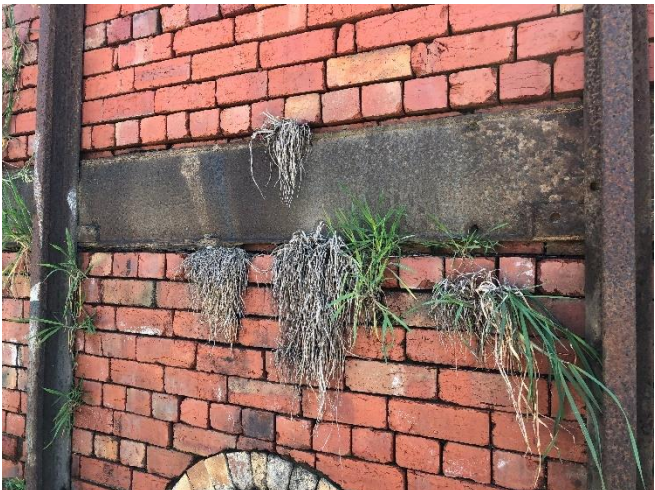
| Photographs | Observation |
|---|---|
| | <p>Photograph 21</p> <hr/> <p><b>Observation:</b> Vegetation growth compromising mortar.</p> <p><b>Location:</b> Side (south) elevation.</p> |

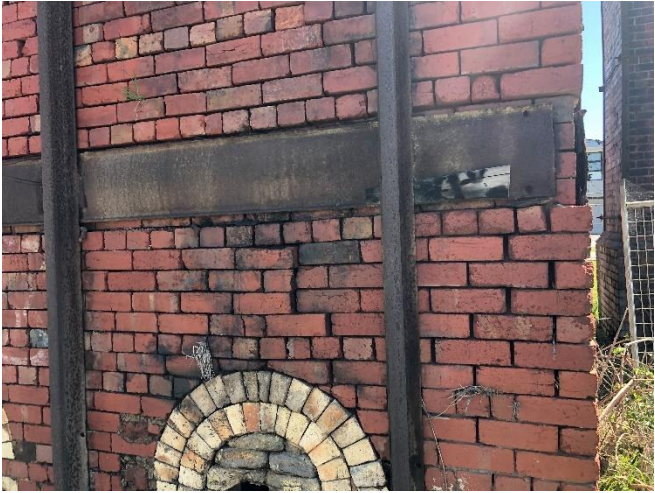
| Photographs | Observation |
|---|---|
| | <p>Photograph 22</p> <hr/> <p><b>Observation:</b> Brick displacement and separation. Mortar erosion.</p> <p><b>Location:</b> Side (south) elevation.</p> |

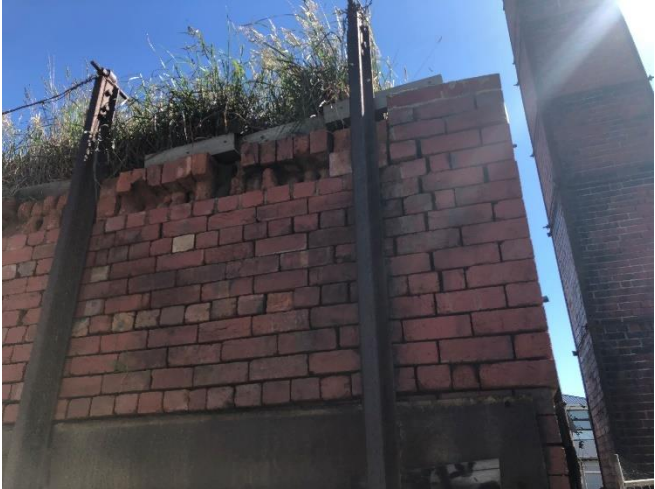
| Photographs | Observation |
|---|---|
| | <p>Photograph 23</p> <hr/> <p><b>Observation:</b> Missing bricks. Brick displacement and separation. Mortar erosion.</p> <p><b>Location:</b> Side (south) elevation.</p> |

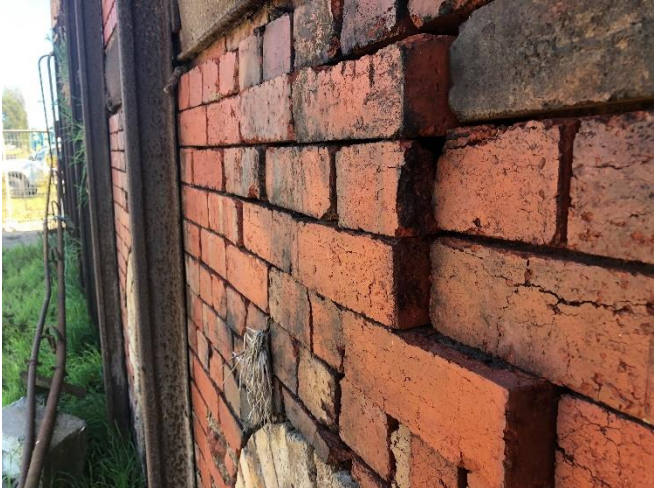
| Photographs | Observation |
|---|---|
| | <p>Photograph 24</p> <hr/> <p><b>Observation:</b> Brick displacement.</p> <p><b>Location:</b> Side (south) elevation.</p> |

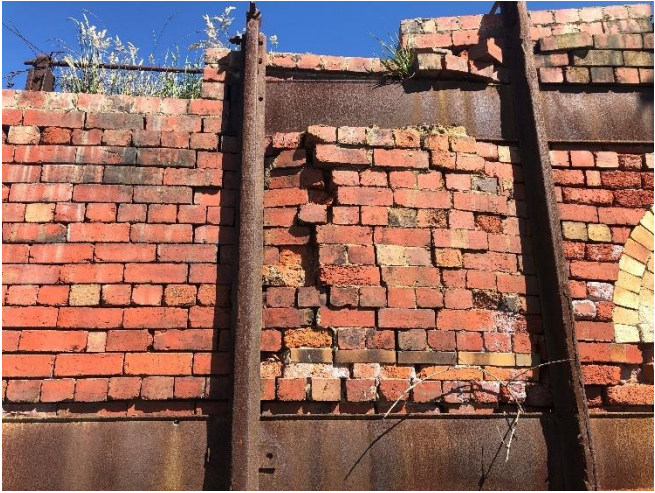
| Photographs | Observation |
|---|---|
| | <p>Photograph 25</p> <hr/> <p><b>Observation:</b> Brick wall bulging. Brick displacement and separation. Mortar erosion.</p> <p><b>Location:</b> Rear (east) elevation.</p> |

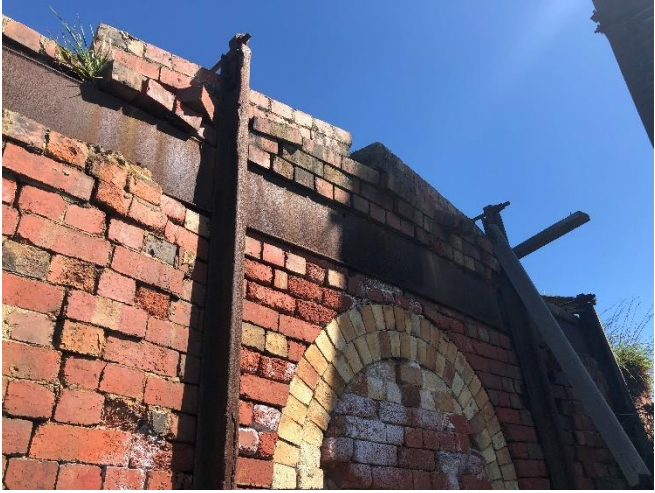
| Photographs | Observation |
|---|---|
| | <p>Photograph 26</p> <hr/> <p><b>Observation:</b> Brickwork cracking and separation. Mortar erosion. Unstable brickwork.</p> <p><b>Location:</b> Rear (east) elevation.</p> |

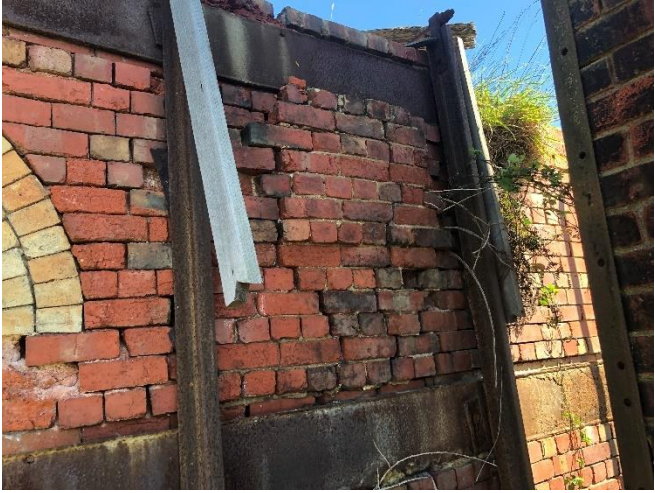
| Photographs | Observation |
|---|---|
| | <p>Photograph 27</p> <hr/> <p><b>Observation:</b> Brick displacement and separation. Mortar erosion.</p> <p><b>Location:</b> Rear (east) elevation.</p> |

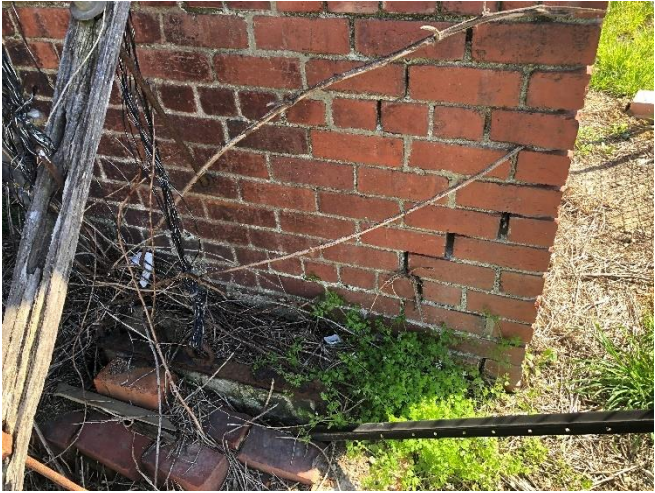
- 2) The chimney tower cracking and mortar is categorizable as moderate and requires at a minimum re pointing including repair/reinstatement of brickwork in some locations to varying extents to restore structural integrity.

| Photographs | Observation |
|---|---|
| | <p>Photograph 28</p> <hr/> <p><b>Observation:</b> Stepped brickwork cracking</p> <p><b>Location:</b> Chimney tower.</p> |

This office recommends that chimney tower have its mortar repointed with similar/appropriate lime based mortar. A suitably qualified and experienced tradesperson should be engaged to undertake works.

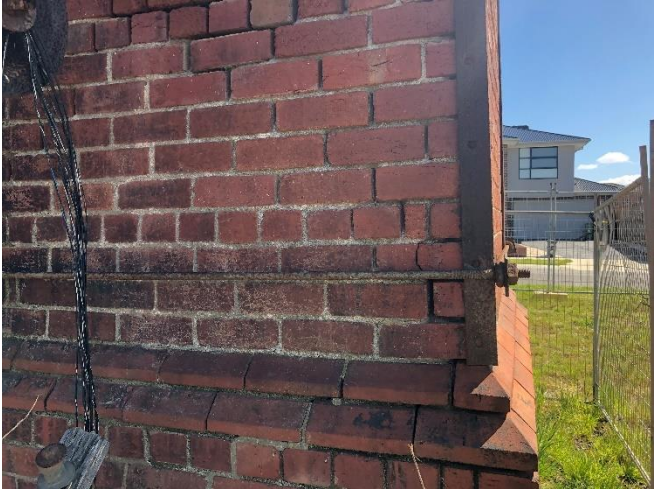
| Photographs | Observation |
|---|---|
| | <p>Photograph 29</p> <hr/> <p><b>Observation:</b> Stepped brickwork cracking</p> <p><b>Location:</b> Chimney tower.</p> |

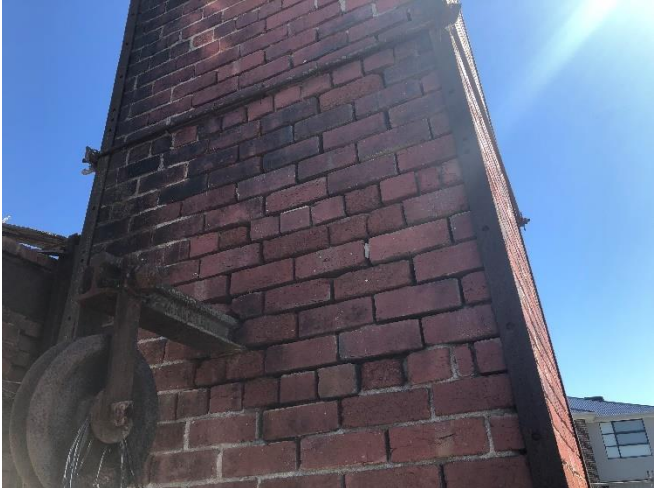
| Photographs | Observation |
|---|---|
| | <p>Photograph 30</p> <hr/> <p><b>Observation:</b> Mortar erosion.</p> <p><b>Location:</b> Chimney tower.</p> |

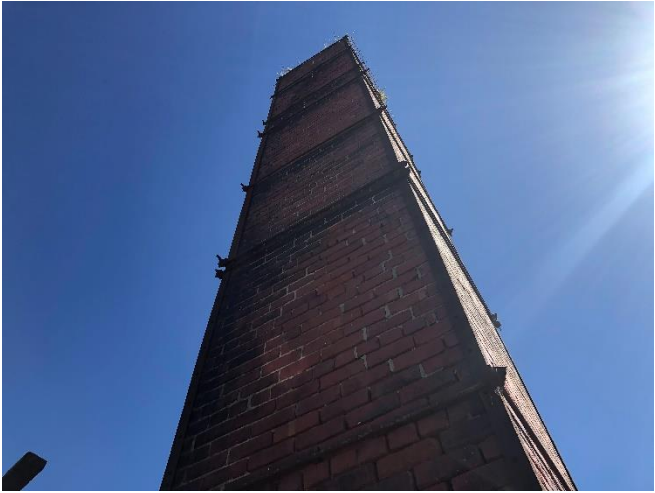
| Photographs | Observation |
|---|---|
| | <p>Photograph 31</p> <hr/> <p><b>Observation:</b> General condition.</p> <p><b>Location:</b> Chimney tower.</p> |

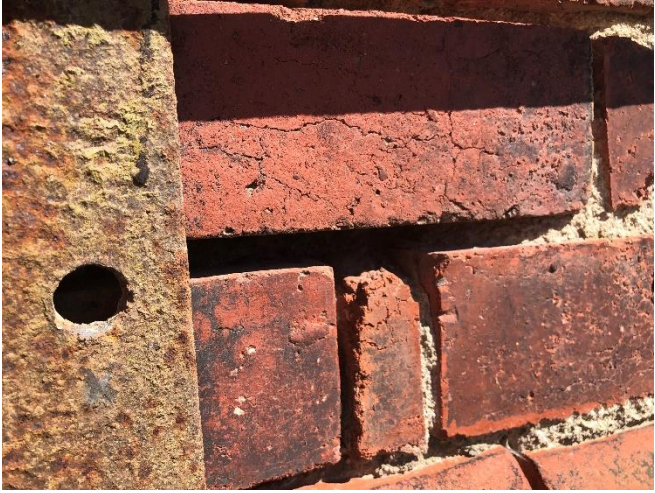
| Photographs | Observation |
|---|---|
| | <p>Photograph 32</p> <hr/> <p><b>Observation:</b> Mortar erosion.</p> <p><b>Location:</b> Chimney tower.</p> |

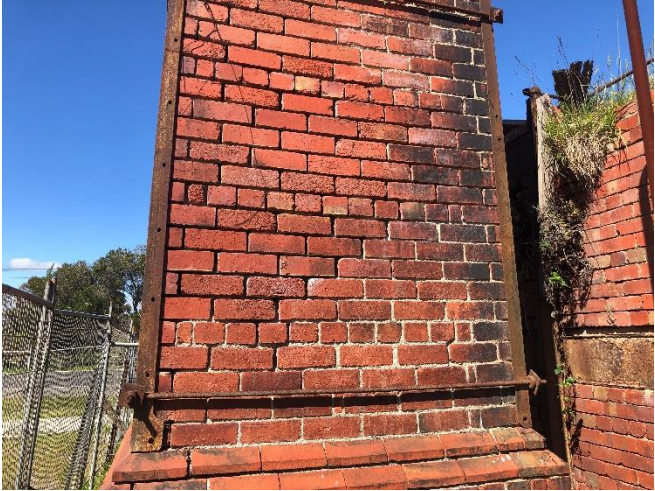
| Photographs | Observation |
|---|---|
| | <p>Photograph 33</p> <hr/> <p><b>Observation:</b> Stepped brickwork cracking and mortar erosion.</p> <p><b>Location:</b> Chimney tower.</p> |

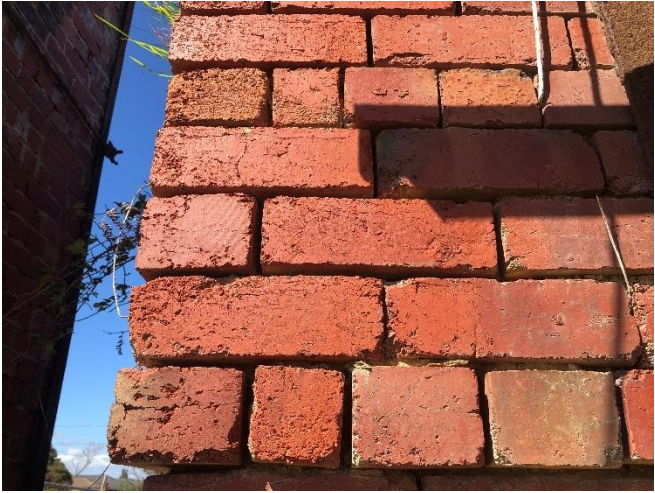
| Photographs | Observation |
|---|---|
| | <p>Photograph 34</p> <hr/> <p><b>Observation:</b> Mortar erosion.</p> <p><b>Location:</b> Side (north) elevation.</p> |

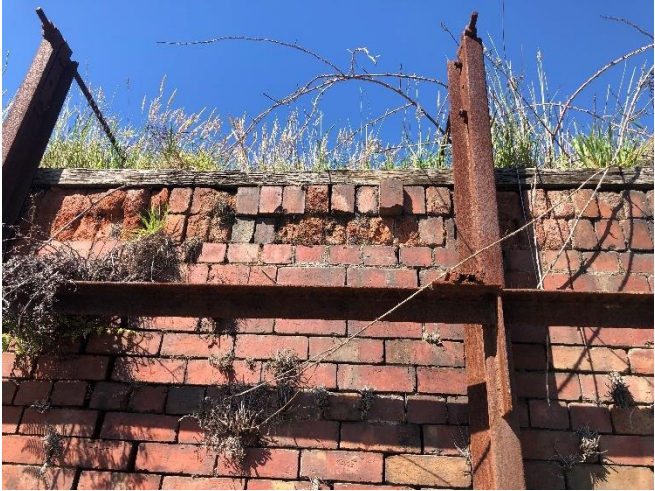
Brickwork erosion has been noted in the upper section of the kiln structure at a number of points. This is not to be unexpected in a 100+ year old structure due to the lower quality/strength brickwork.

| Photographs | Observation |
|---|---|
| | <p>Photograph 35</p> <hr/> <p><b>Observation:</b> Brickwork erosion.</p> <p><b>Location:</b> Side (north) elevation.</p> |

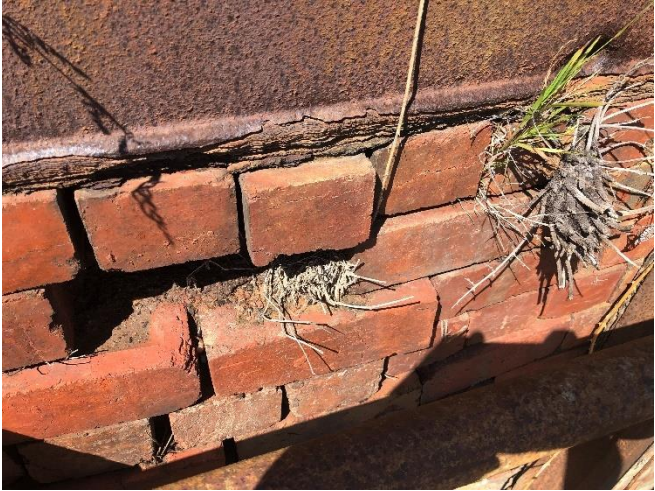
| Photographs | Observation |
|---|---|
| | <p>Photograph 36</p> <hr/> <p><b>Observation:</b> Brickwork displacement.</p> <p><b>Location:</b> Side (north) elevation.</p> |

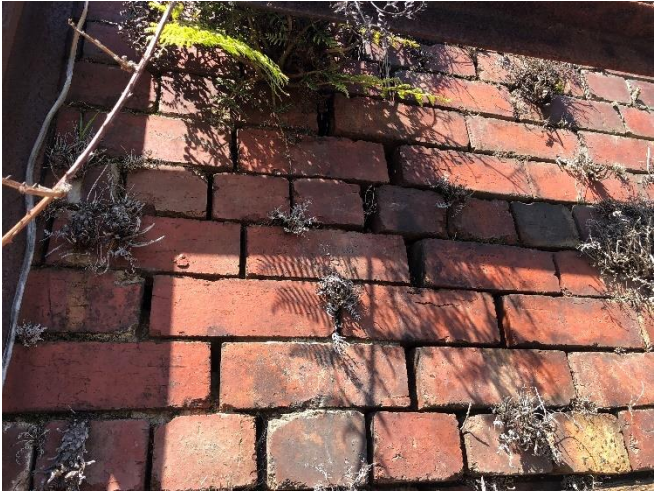
| Photographs | Observation |
|---|---|
| | <p>Photograph 37</p> <hr/> <p><b>Observation:</b> Brick displacement and separation. Mortar erosion.</p> <p><b>Location:</b> Side (north) elevation.</p> |

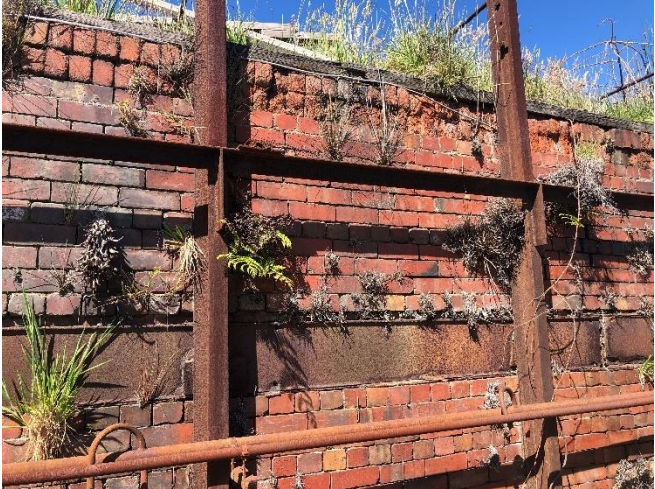
| Photographs | Observation |
|---|---|
| | <p>Photograph 38</p> <hr/> <p><b>Observation:</b> Vegetation growth compromising mortar.</p> <p><b>Location:</b> Side (north) elevation.</p> |

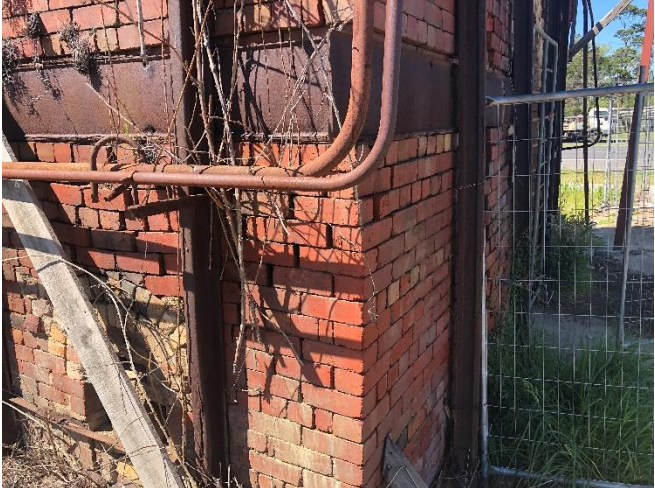
| Photographs | Observation |
|---|---|
| | <p>Photograph 39</p> <hr/> <p><b>Observation:</b> Stepped brickwork cracking</p> <p><b>Location:</b> Side (north) elevation.</p> |

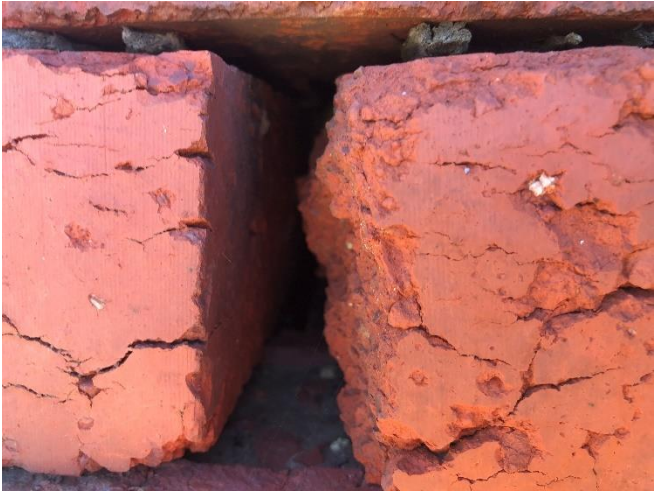
| Photographs | Observation |
|---|---|
| | <p>Photograph 40</p> <hr/> <p><b>Observation:</b> Mortar erosion.</p> <p><b>Location:</b> Side (north) elevation.</p> |

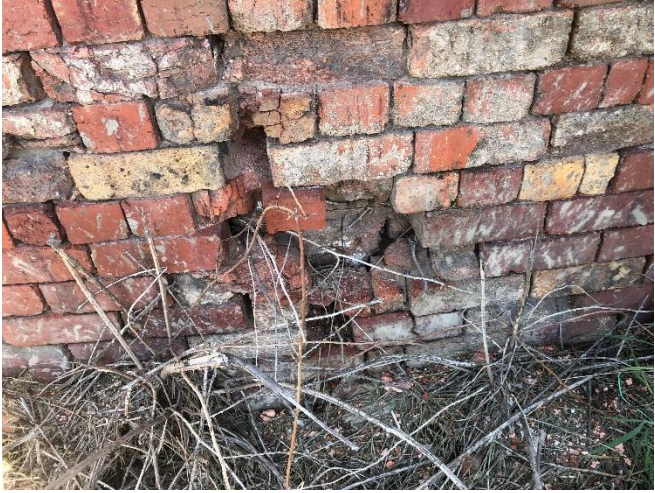
| Photographs | Observation |
|---|---|
| | <p>Photograph 41</p> <hr/> <p><b>Observation:</b> Damaged brickwork.<br/>Missing bricks.</p> <p><b>Location:</b> Side (north) elevation.</p> |

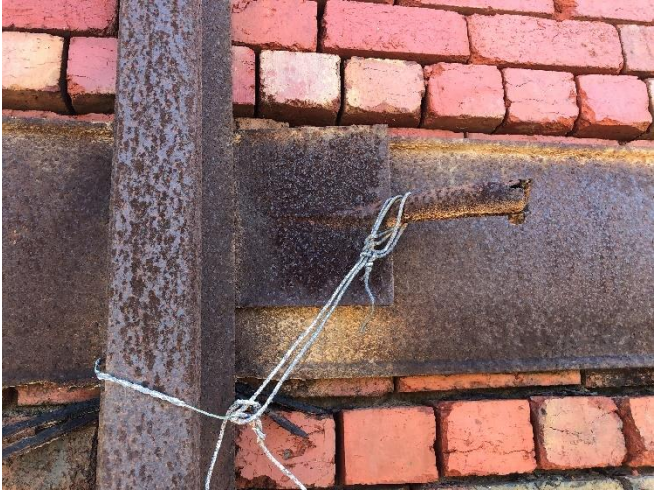
| Photographs | Observation |
|---|---|
| | <p>Photograph 42</p> <hr/> <p><b>Observation:</b> Makeshift structural repairs.</p> <p><b>Location:</b> Side (south) elevation.</p> |

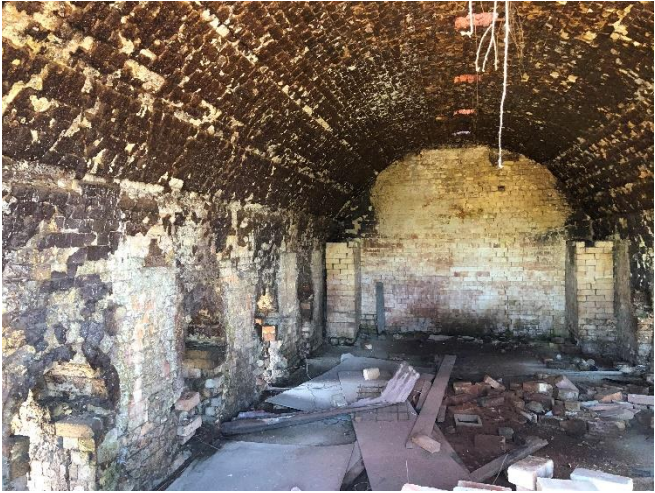
| Photographs | Observation | | | | |
|---|---|---|---|---|---|
| | <p data-bbox="826 421 1023 454">Photograph 43</p> <hr data-bbox="826 465 1385 470"/> <table> <tr> <td data-bbox="826 510 1007 544"><b>Observation:</b></td><td data-bbox="1038 495 1246 566">General interior condition.</td></tr> <tr> <td data-bbox="826 600 959 633"><b>Location:</b></td><td data-bbox="1038 600 1134 633">Interior</td></tr> </table> | <b>Observation:</b> | General interior condition. | <b>Location:</b> | Interior |

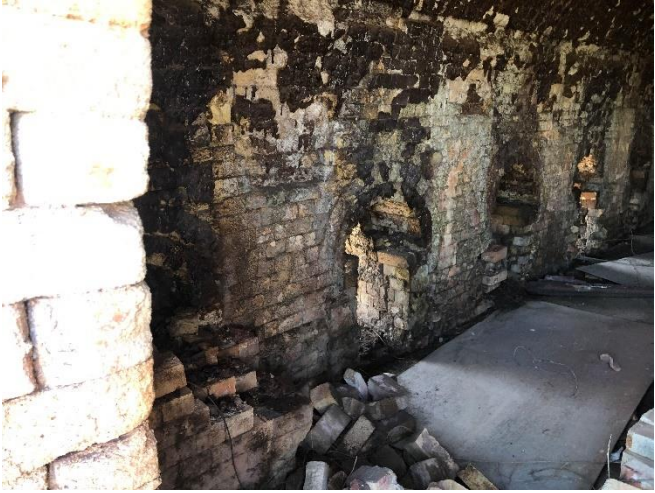
| Photographs | Observation | | | | |
|---|---|---|---|---|---|
| | <p data-bbox="826 943 1023 976">Photograph 44</p> <hr data-bbox="826 987 1385 992"/> <table> <tr> <td data-bbox="826 1032 1007 1066"><b>Observation:</b></td><td data-bbox="1038 1016 1246 1088">General interior condition.</td></tr> <tr> <td data-bbox="826 1122 959 1155"><b>Location:</b></td><td data-bbox="1038 1122 1134 1155">Interior</td></tr> </table> | <b>Observation:</b> | General interior condition. | <b>Location:</b> | Interior |

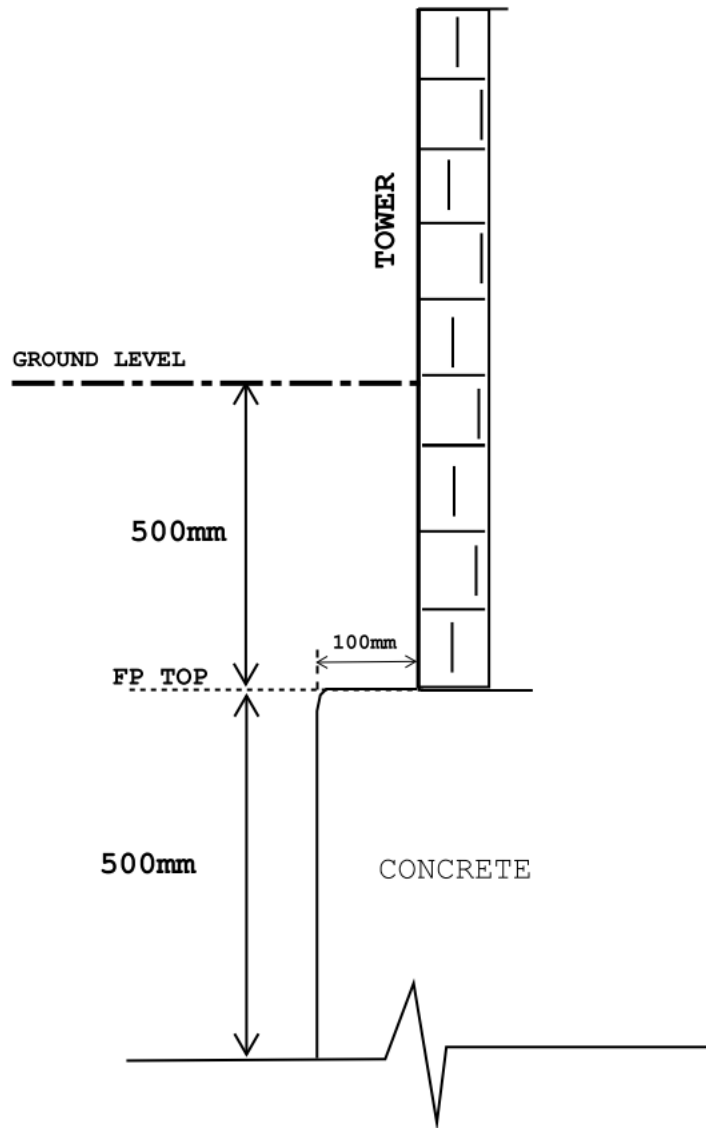
## Footing Probe 1

**FOOTING PROBE STOPPED DUE TO DEPTH  
FP BOTTOM NOT FOUND**

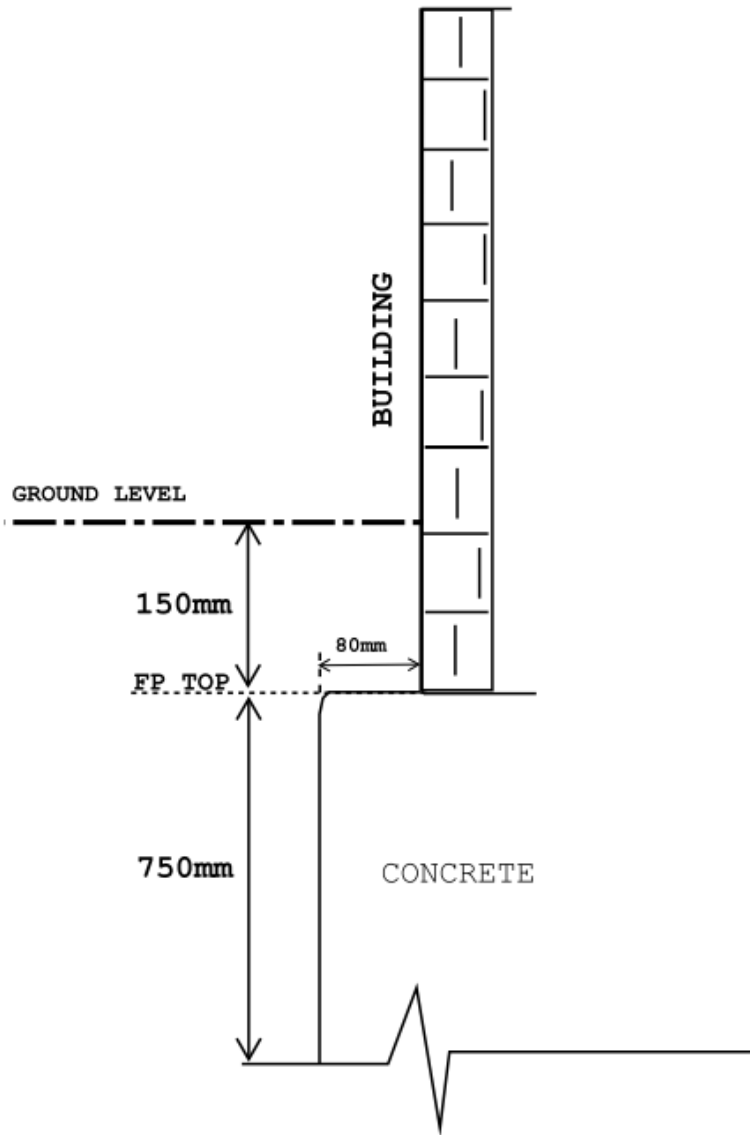
## Footing Probe 2

**FOOTING PROBE STOPPED DUE TO DEPTH  
FP BOTTOM NOT FOUND**
