Keymore Pty Ltd

Preliminary Environmental and  
Hydrogeological Site Investigation  
365 Princes Highway, Officer

May 2014

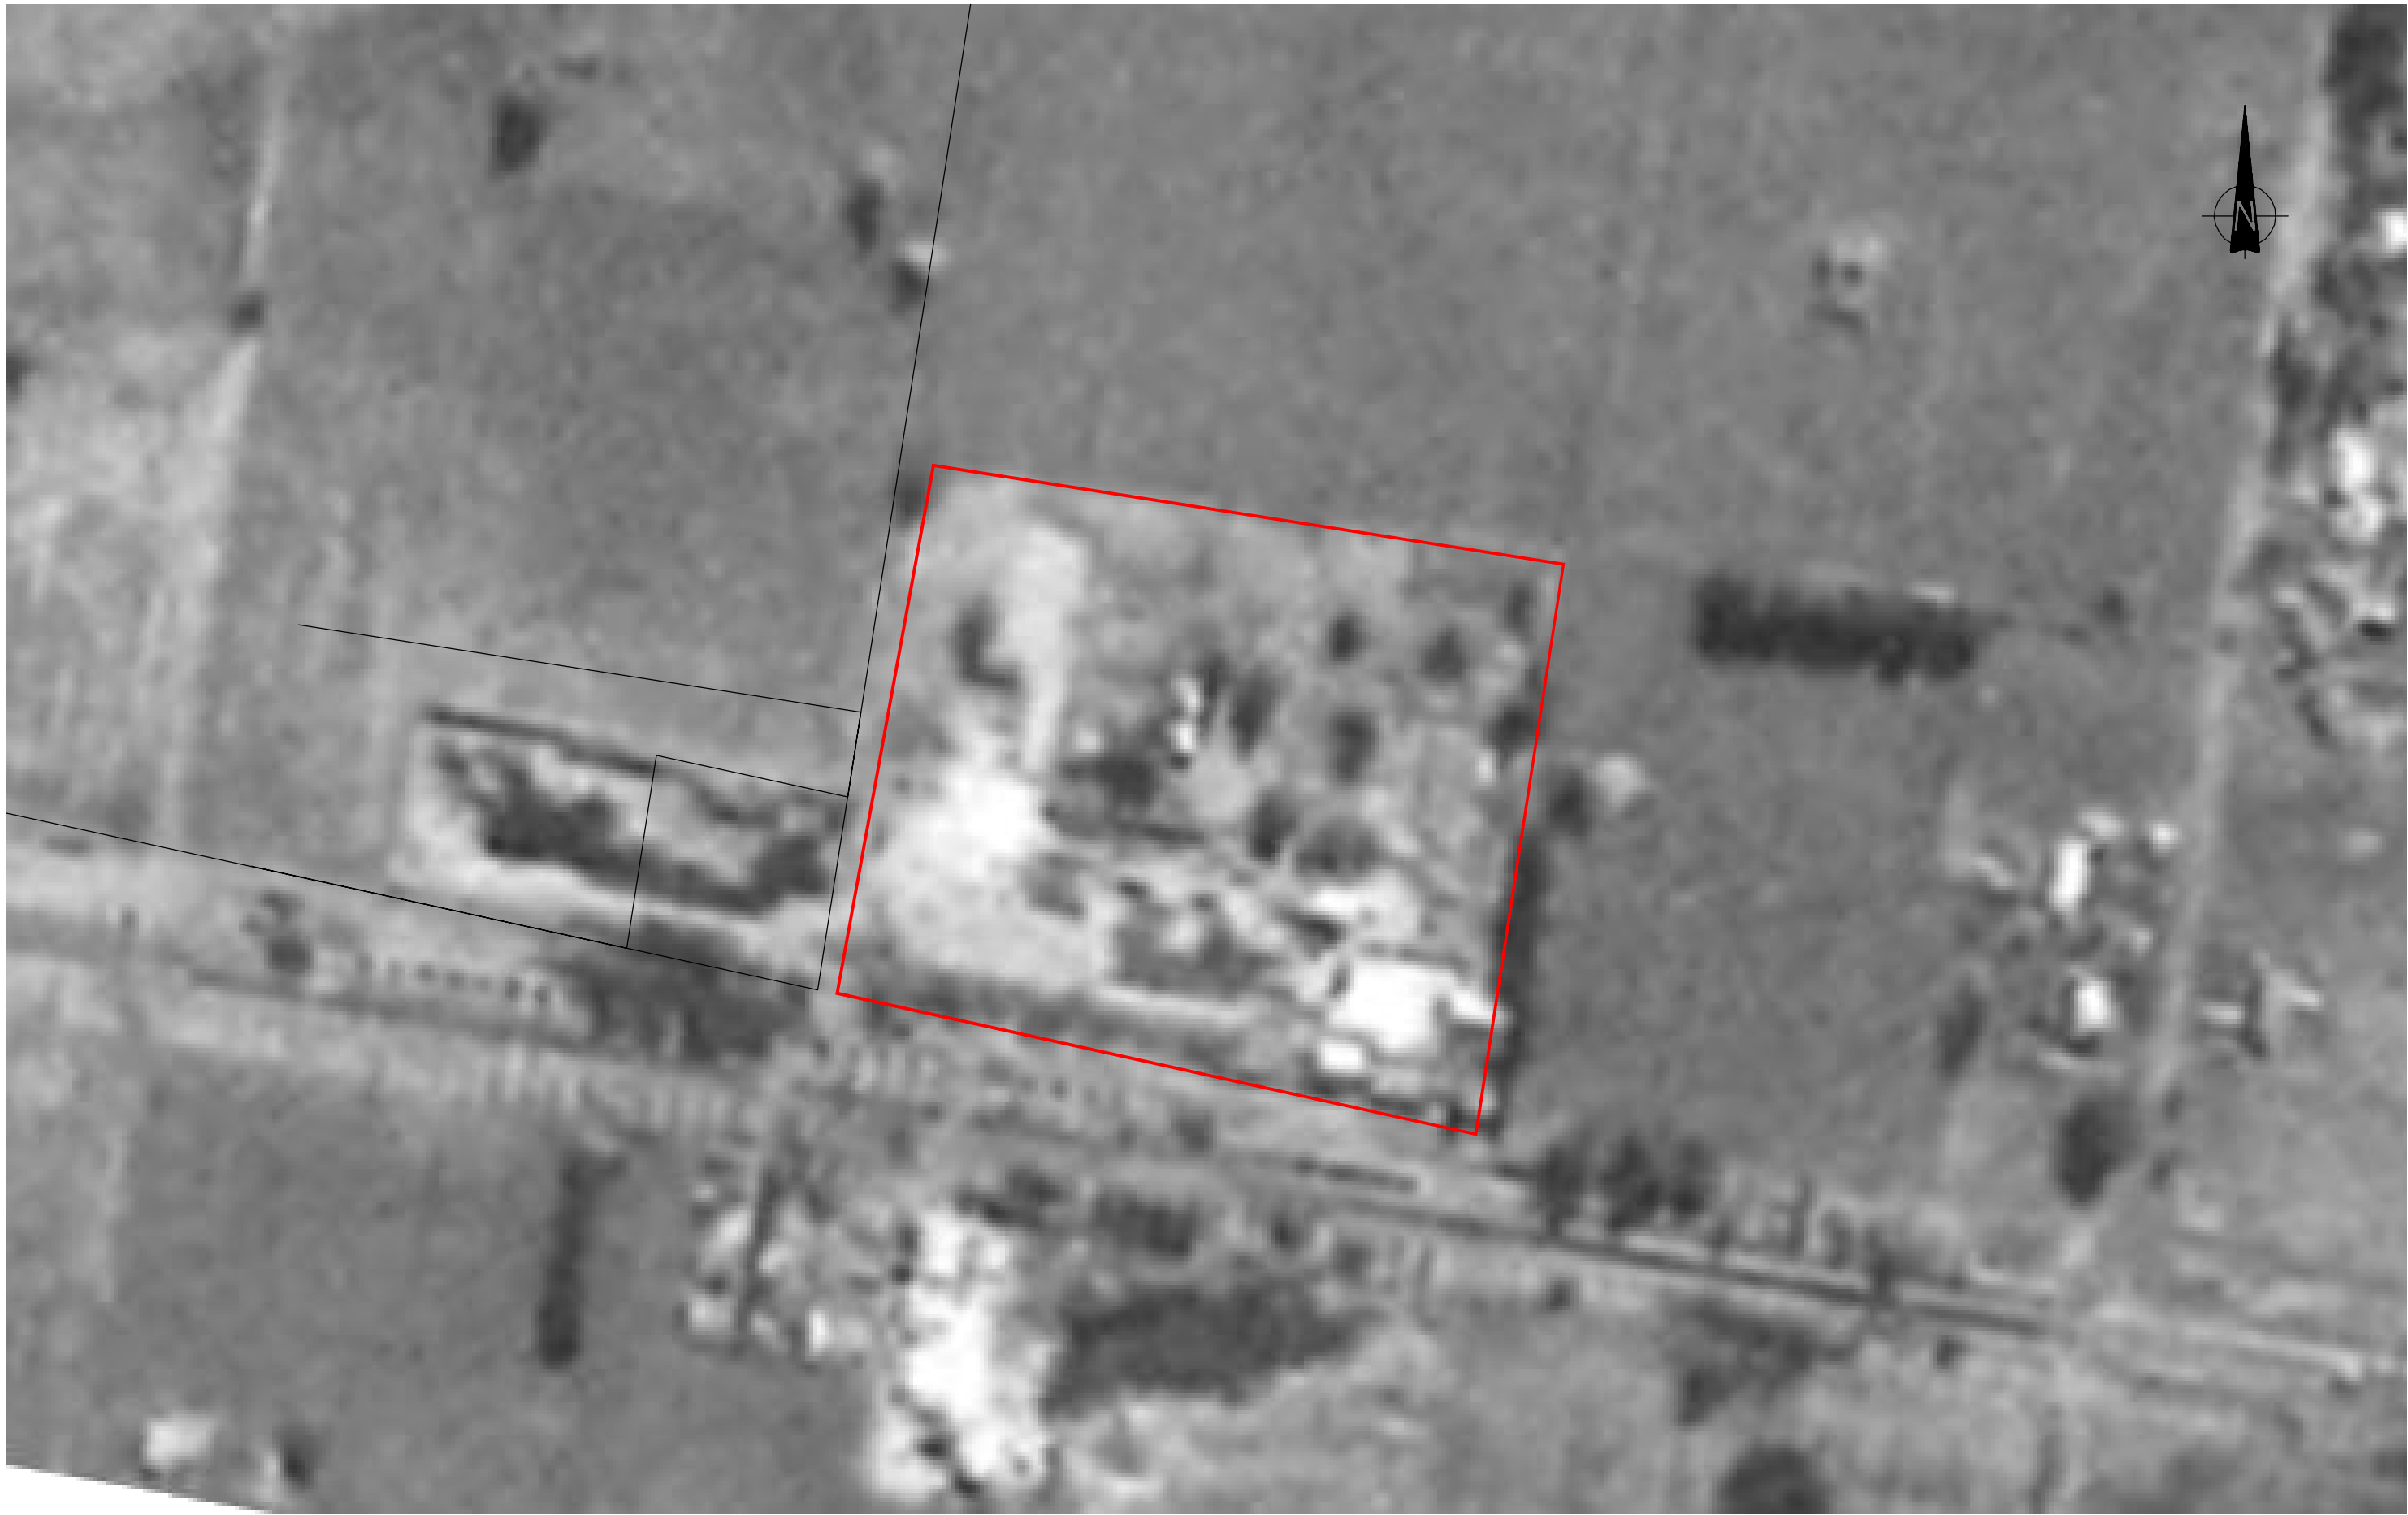
| FIG. No. | Figure 3 | REV. 0 |

| Photograph | Observations |
|---|---|
| <p>July 1973<br/>Run: 3 Film: 2800 Photo: 5<br/>Project: Beaconsfield to Robinhood 1973 Bushfires 1973<br/>Scale: 1:12,000</p> | <p><b>Site Observations</b><br/>The site appears largely unchanged from the previous image, with the exception of the quarry/pit being extended to the north along the western site boundary.</p> <p><b>Site Surrounds Observations</b><br/>No significant changes were noted on the surrounding land from the previous image.</p> |

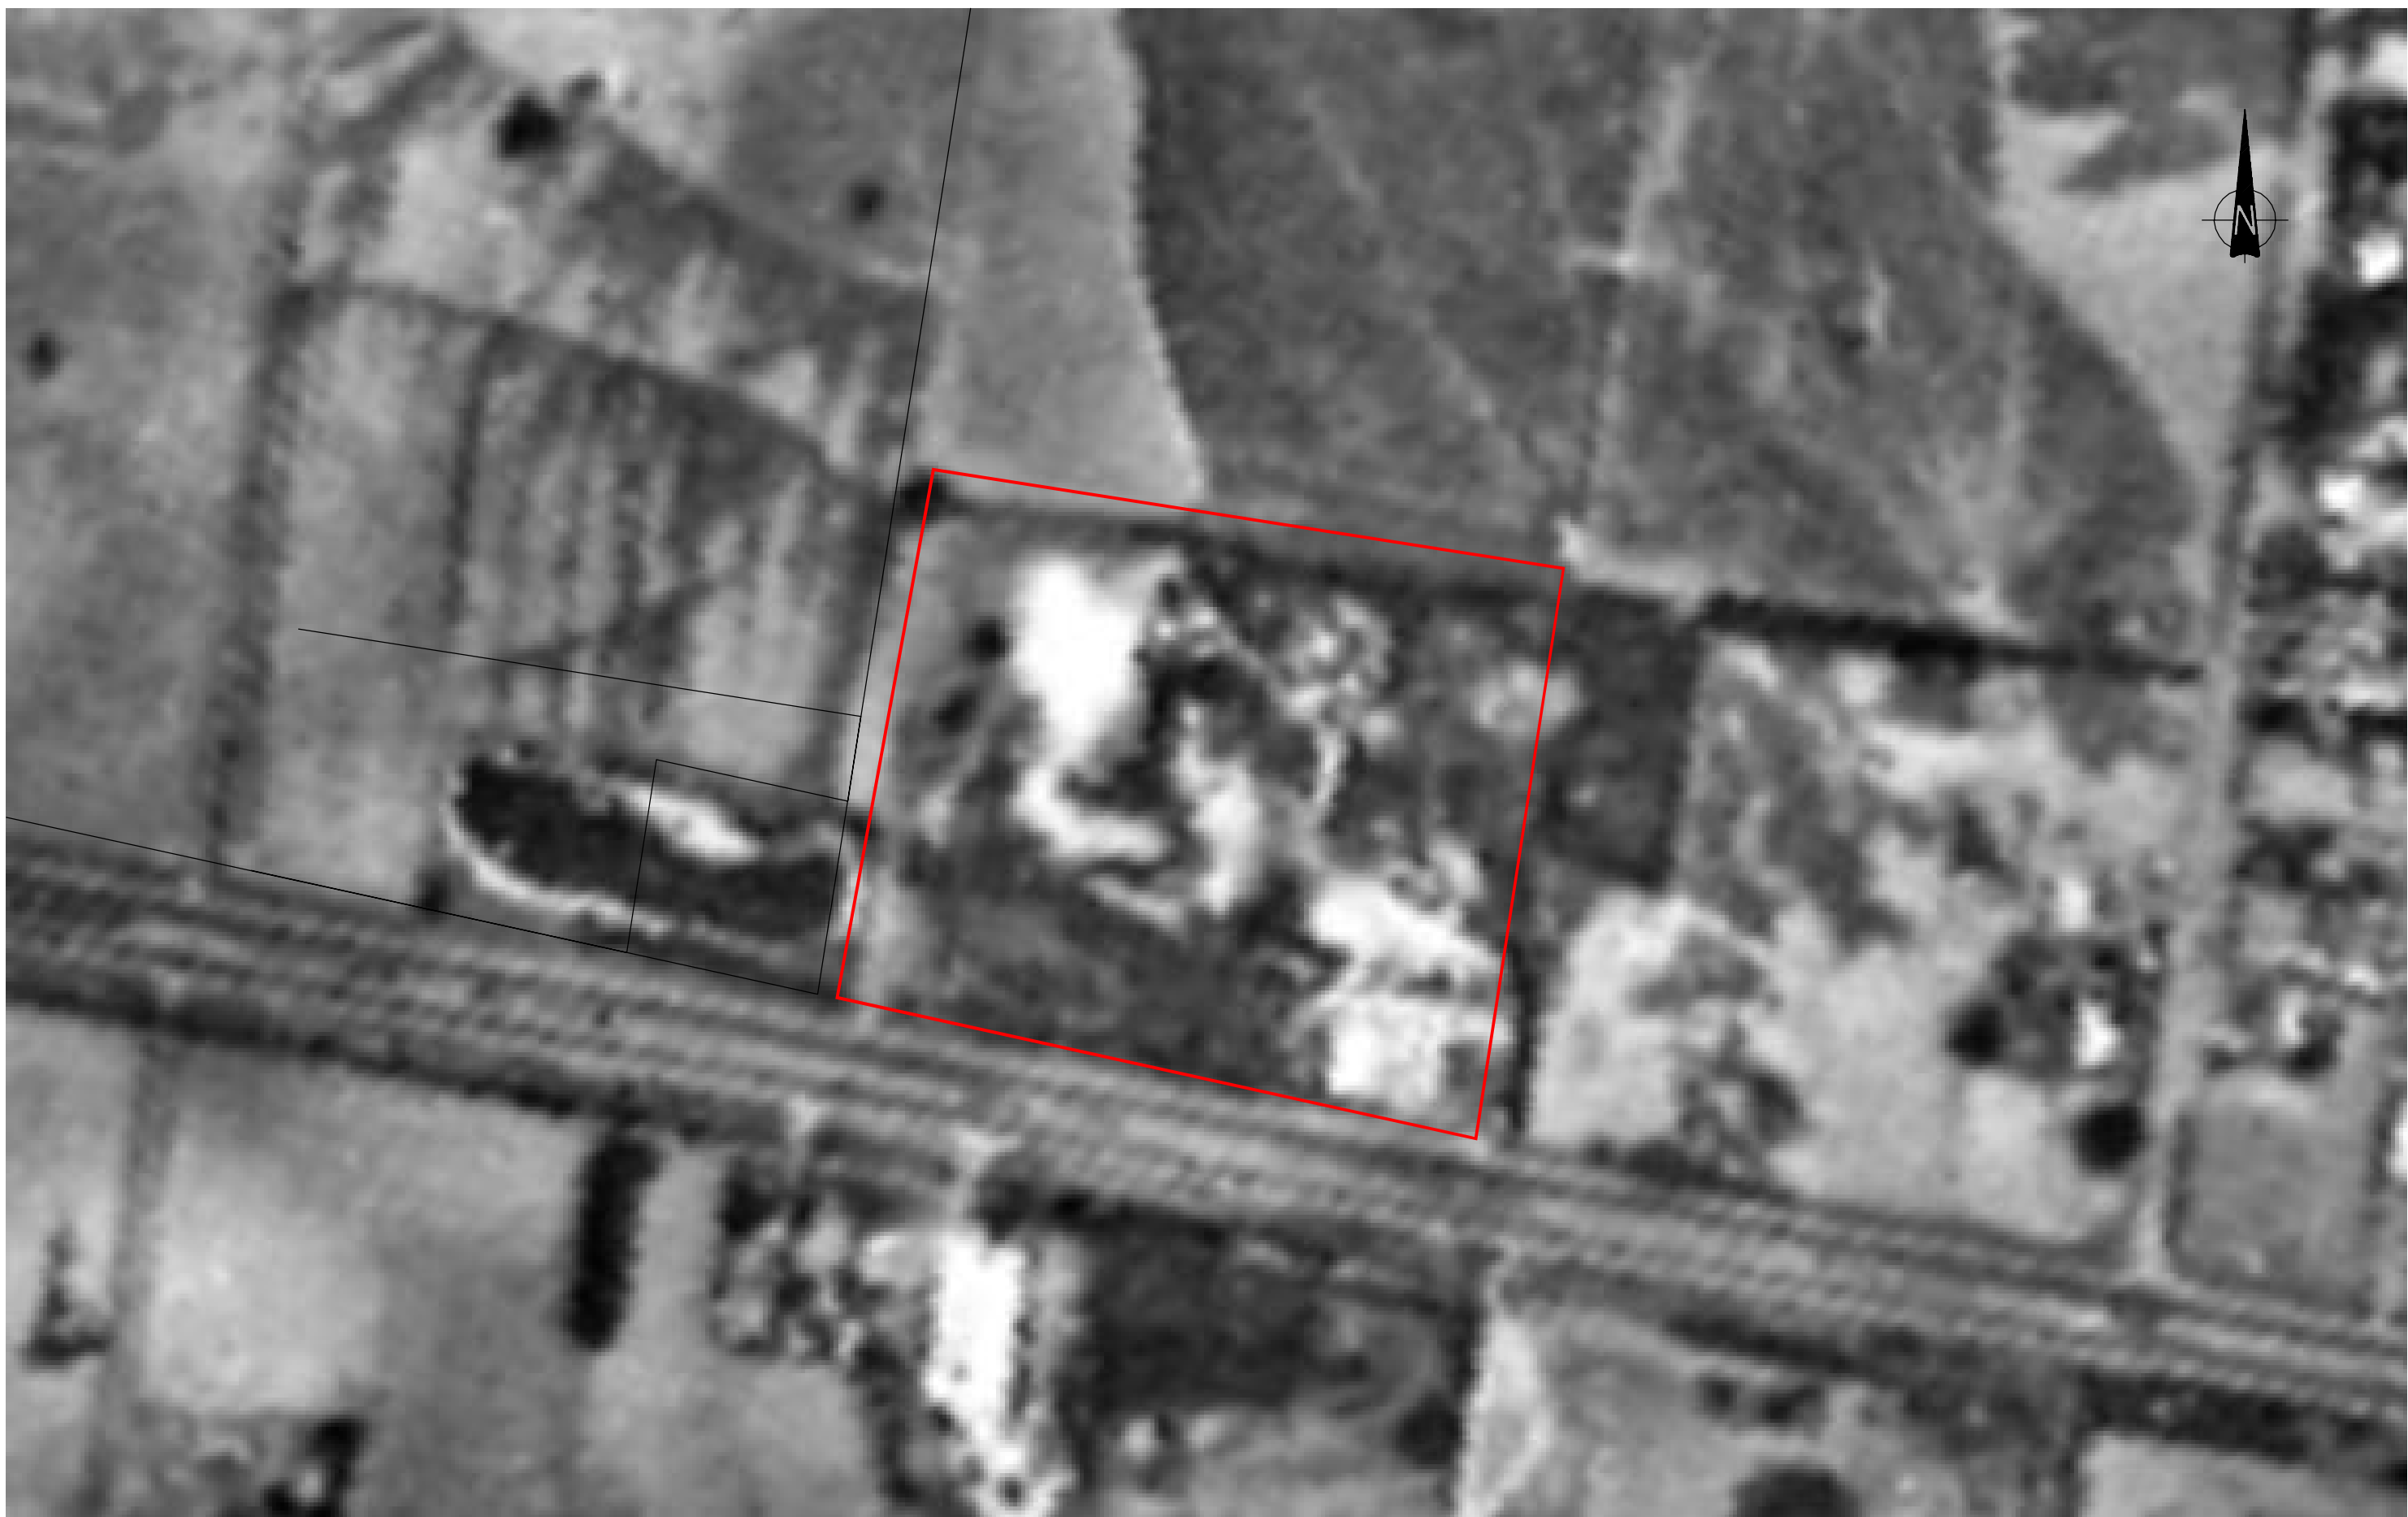
| FIG. No. | Figure 4 | REV. 0 |

| Photograph | Observations |
|---|---|
| <p>February 1983<br/>Run: 5 Film: 3751 Photo: 168<br/>Project: Dandenong Ranges Bushfires Feb 83<br/>Scale: 1:10,000</p> | <p><b>Site Observations</b><br/>The image quality is poor however it appears the buildings in the central northern portion of the site are no longer present. Burnt grassland (indicative of bushfire) is visible in this area of the site and may explain the absence of these structures.</p> <p><b>Site Surrounds Observations</b><br/>The wider aerial photograph shows more substantial burnt areas to the north and south of the site.</p> |

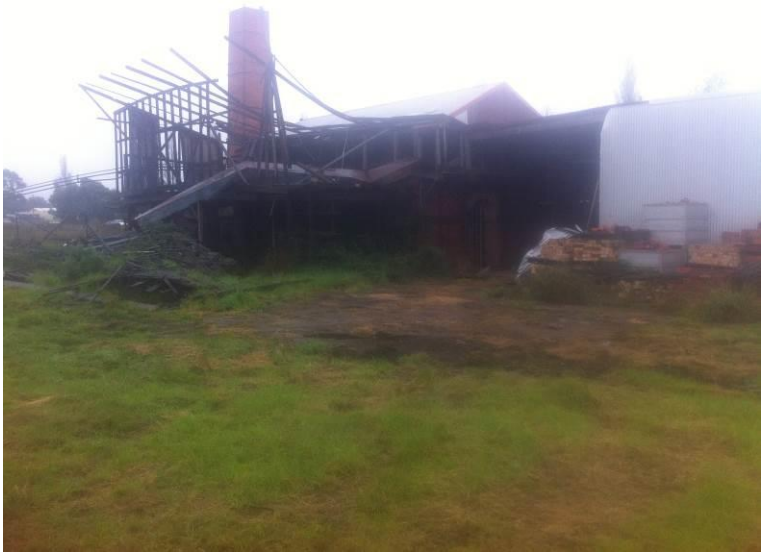
| <p><i>Photograph 1</i></p> <p><i>10/04/2014</i></p> <p><i>Former kiln and pottery factory. Shot taken facing south east.</i></p> | |

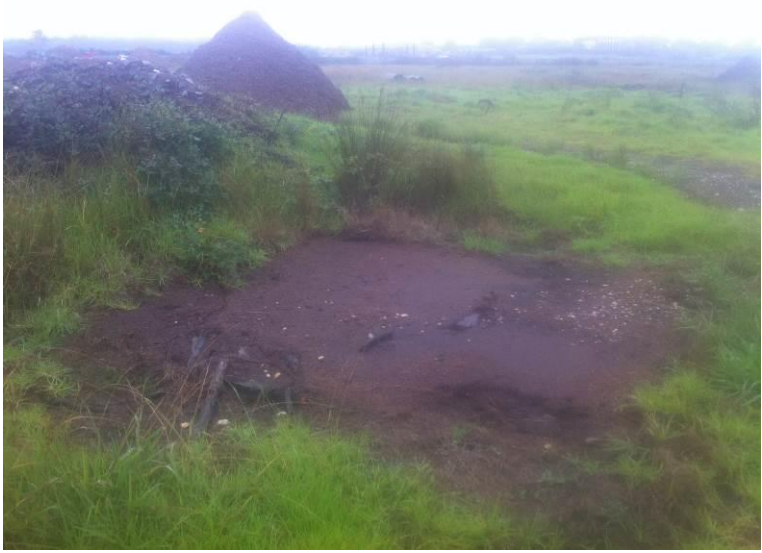
| <p><i>Photograph 2</i></p> <p><i>10/04/2014</i></p> <p><i>Concrete hardstand located to the north of the kiln on the east side of entrance road.</i></p> | |

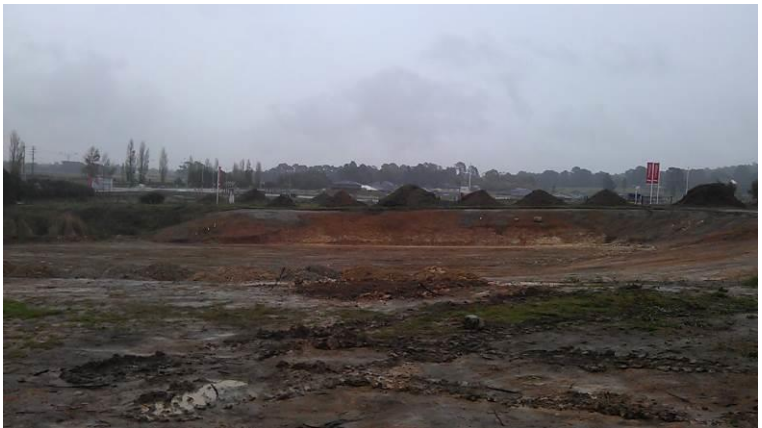
| <p><i>Photograph 3</i></p> <p><i>10/04/2014</i></p> <p><i>Excavation located in the northern portion of the site. Formally part of quarry (now dam) in the south east corner of the site. Stockpiled soils visible on western side of excavation.</i></p> | |

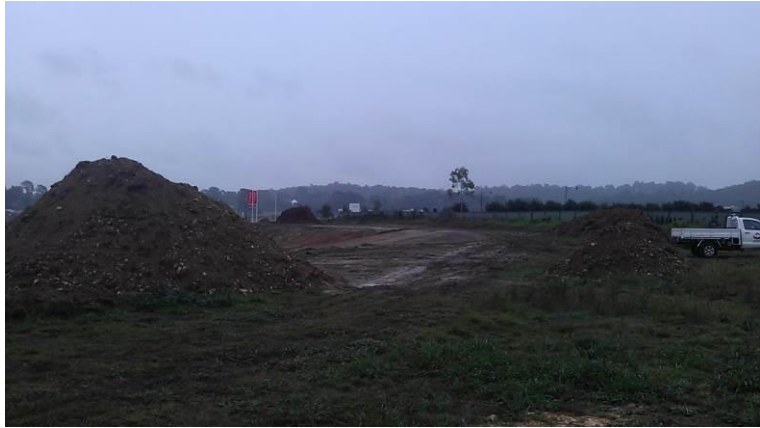
*Photograph 4*

There was a stockpile of corrugated iron sheeting and metal frame work in the centre of the site which is likely to have originated from the shed which previously occupied this location. Approximately a dozen soil stockpiles were identified at various locations across the site, several of which, located towards the centre of the site appeared to have originated from the excavation in this area based on the similar soils observed.

*Example of soil stockpiles identified at several location across site.*

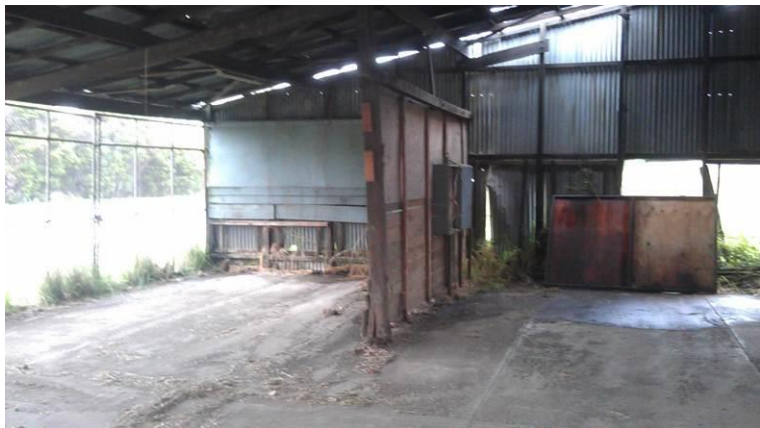
*Photograph 5*

There is one three roomed shed on the site, the shed is located on the south eastern corner adjacent to the driveway. It appeared disused and dilapidated, the north eastern of the three rooms contained the remnants of several inbuilt ovens or kilns, the remaining two rooms were found to be empty. There was storage of bricks and terracotta pipes on the northern side of the shed. An area of hardstand (i.e. concrete), which was approximately 3.5m by 3m in size, was identified adjacent to the driveway, to the north of the shed. The footprint of the previously backfilled section of the quarry has been recently re-excavated. T&T understands that as part of the geotechnical assessment, fill material that had been deposited at this location was being removed as it was geotechnically unsuitable. A dam (formally the quarry/pit) was identified occupying the southwest corner of the site and was full of water at the time of inspection.

*North eastern room of pottery factory, concrete flooring.*

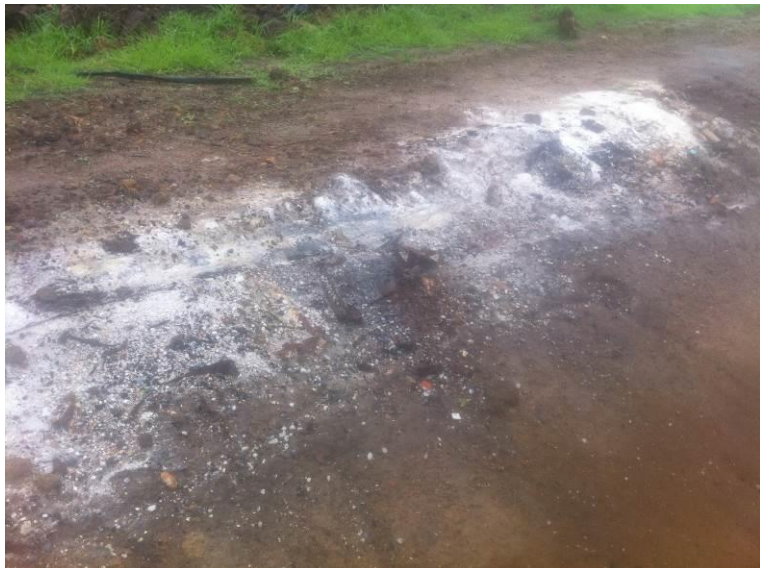
*Photograph 6*

Soils within the incineration pit on the eastern side of the excavation in the north of the site exhibited discoloured soils (grey-white). Solid inert waste in the form of scrap metal, brick, ceramic and some fragments of potential ACM were identified in the incineration pit. A minor quantity of asphalt, possibly associated with the driveway was noted near the site entrance in the south east. Some building debris (e.g. brick, pieces of metal, etc.) was noted in the vicinity of

*Exposed incineration pit on east side of excavation.*

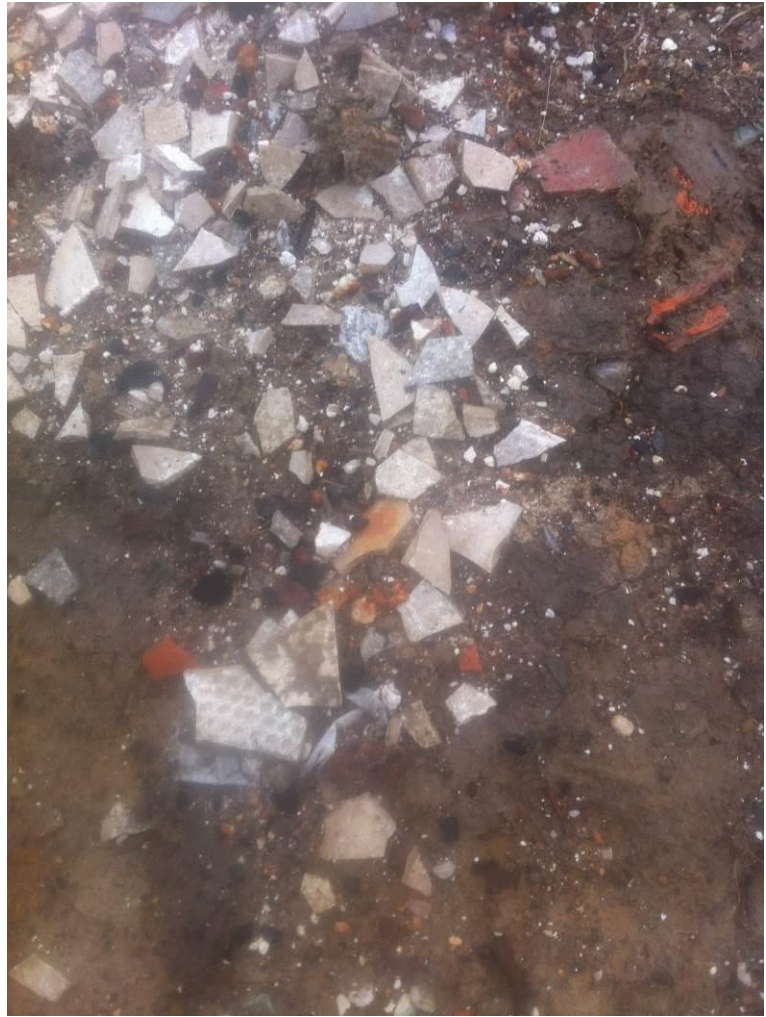
*Photograph 7*

- Concentrations for zinc exceeding adopted ecological criterion (EILs for urban residential and public open space) identified at one sampling location (TP11).
- Fragments of fibro-cement sheet potentially containing asbestos identified on the eastern side of the former quarry excavation in the north west corner of site.
- Remnants of a possible incineration pit inclusive of solid inert waste identified on eastern side of the excavation in the north central portion of site.
- Stockpiles of soil observed towards the central portion of site and west of the concrete hardstand area.
- Solid inert waste identified at surface in the vicinity of TP7, TP19 and the pile of building material on the eastern side of the dam.

*Fragments of possible ACM and ceramic and brickwork identified within material comprising incineration pit soils.*

Based on the above summary and conclusions, T&T recommends that prior to the site being suitable for the proposed redevelopment the following tasks are undertaken:

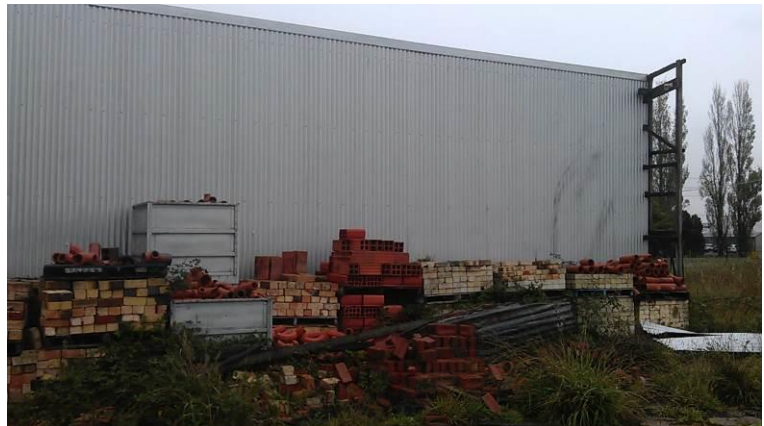
*Photograph 8*

*Storage of ceramic products along northern wall of pottery factory. Shot taken facing Princes Highway.*

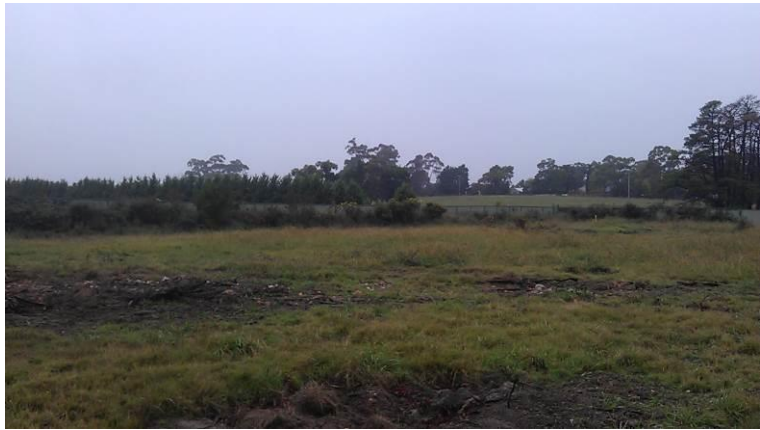
*Photograph 9*

*Testpit TP07 location with building debris (i.e. brickwork etc.) visible in centre left of shot.*

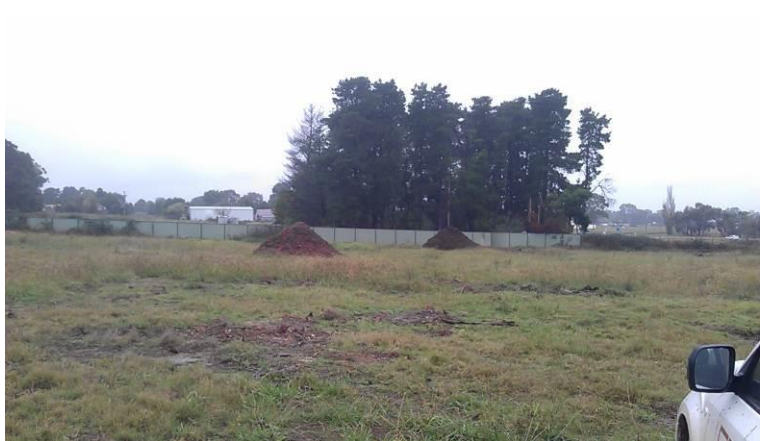
*Photograph 10*

An area of the northeast corner of the site was observed to have two depressions which may have been created from the removal of trees, mulch stockpiles were present in the vicinity.

*Two of the mulch stockpiles identified at the site. Shot showing eastern site boundary in background.*

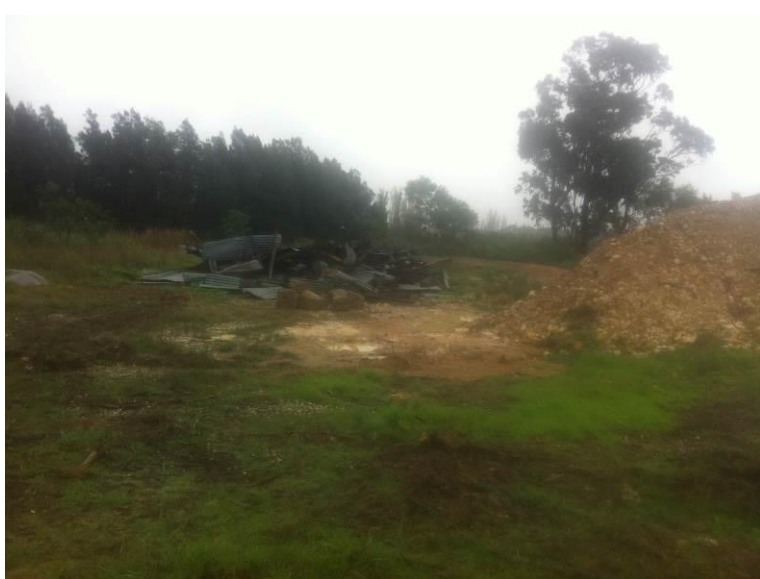
*Photograph 11*

*Stockpile of building material (i.e. corrugated iron sheeting and steel framework) from former shed located to the east of the dam. Soil stockpile of unknown origin in right of shot.*
