# Structural Assessment Report

## **365 Princes Highway, Officer VIC 3809 Prepared for Timbertop East Pty Ltd**

| Report Date: | 19/11/2021 |
| Date of Inspection: | 26/10/2021 |

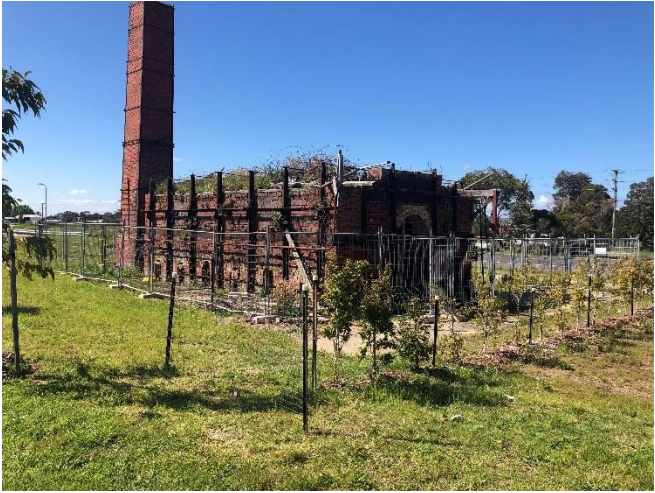
| Photographs | Observation |
|---|---|
| | <p>Photograph 1</p> <hr/> <p><b>Observation:</b> Front (west) elevation.</p> |

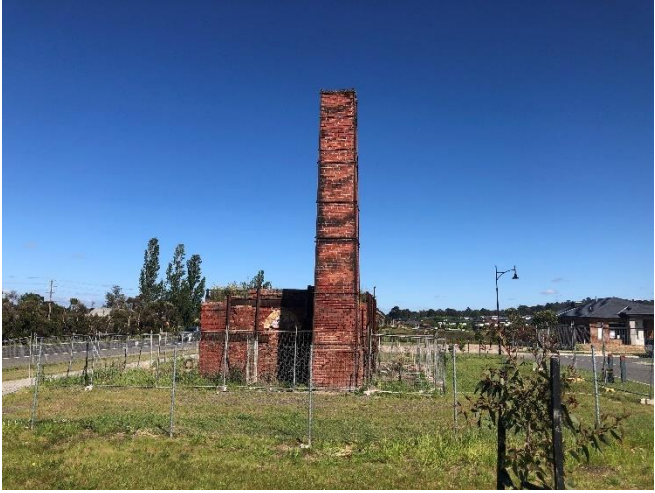
| Photographs | Observation |
|---|---|
| | <p>Photograph 2</p> <hr/> <p><b>Observation:</b> Rear (east) elevation.</p> |

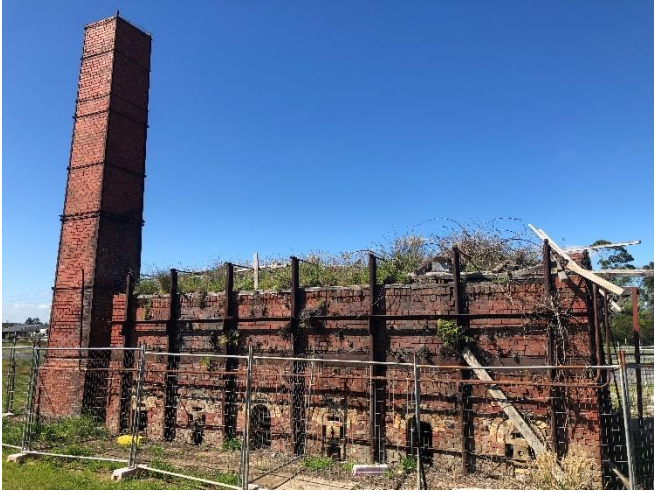
| Photographs | Observation |
|---|---|
| | <p>Photograph 3</p> <hr/> <p><b>Observation:</b> Left-hand side (north). elevation</p> |

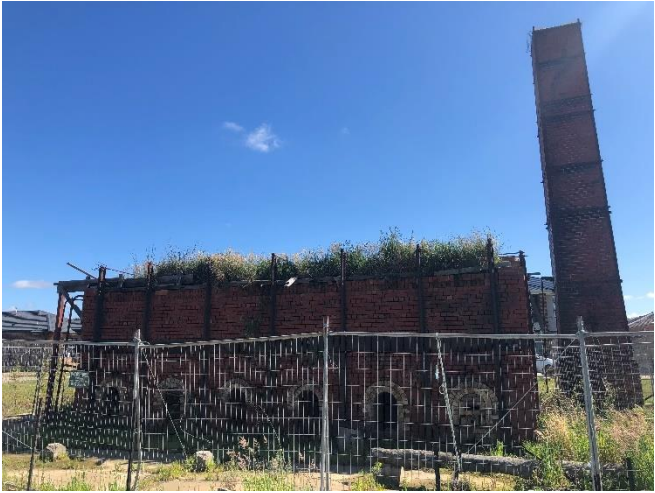
| Photographs | Observation |
|---|---|
| | <p>Photograph 4</p> <hr/> <p><b>Observation:</b> Right-hand side (south) elevation.</p> |

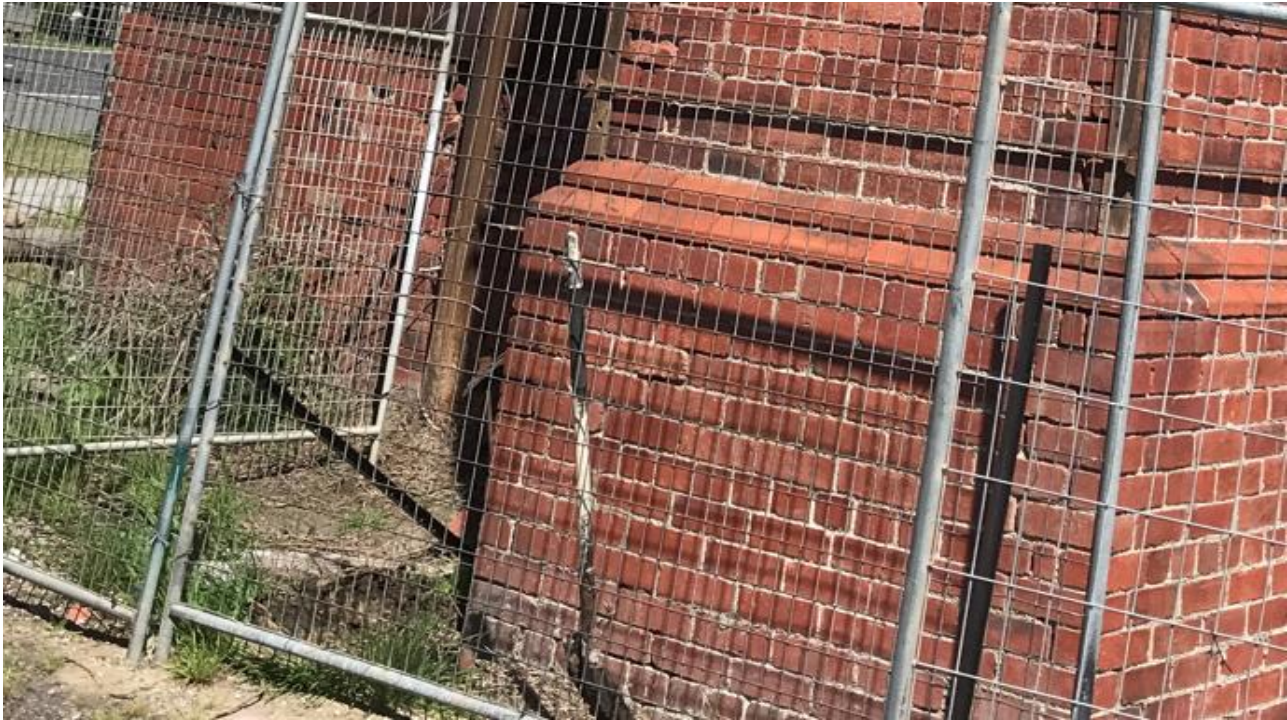
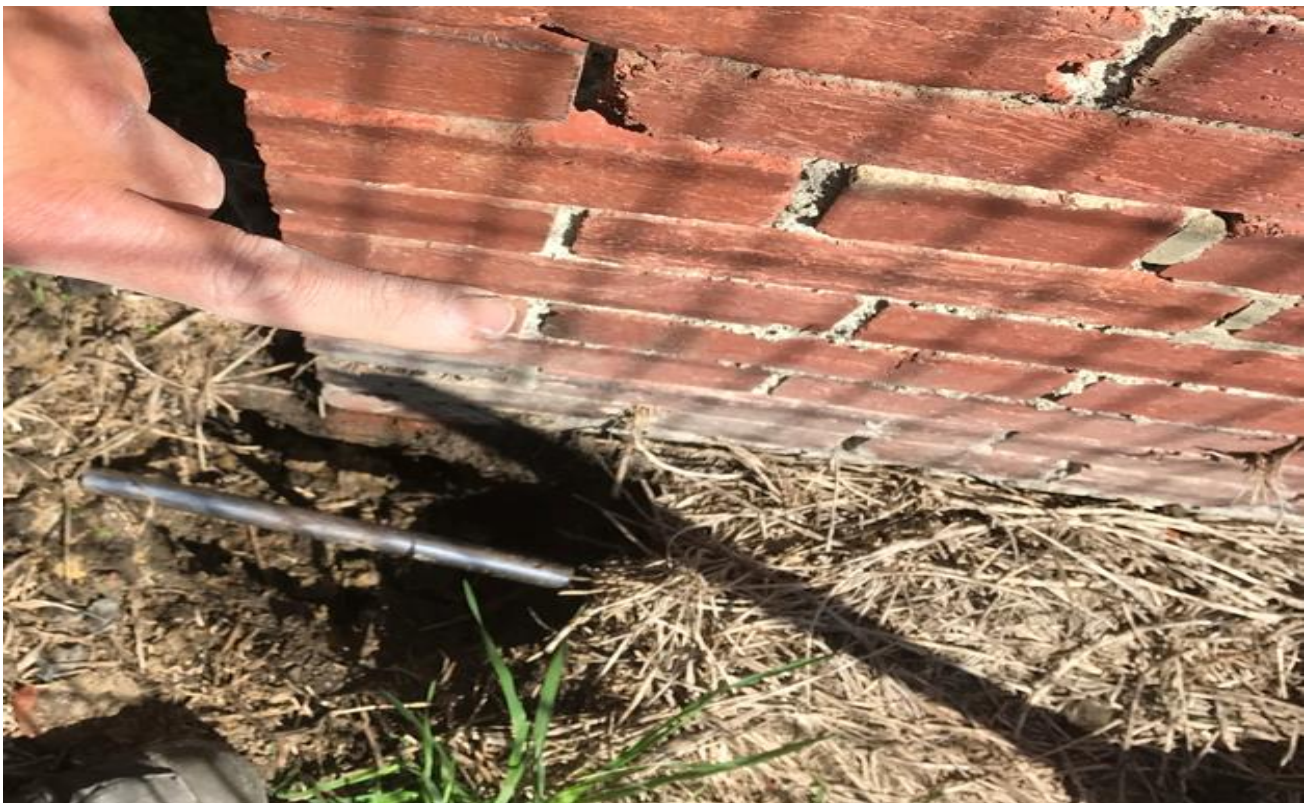
**FOOTING PROBE STOPPED DUE TO DEPTH  
FP BOTTOM NOT FOUND**

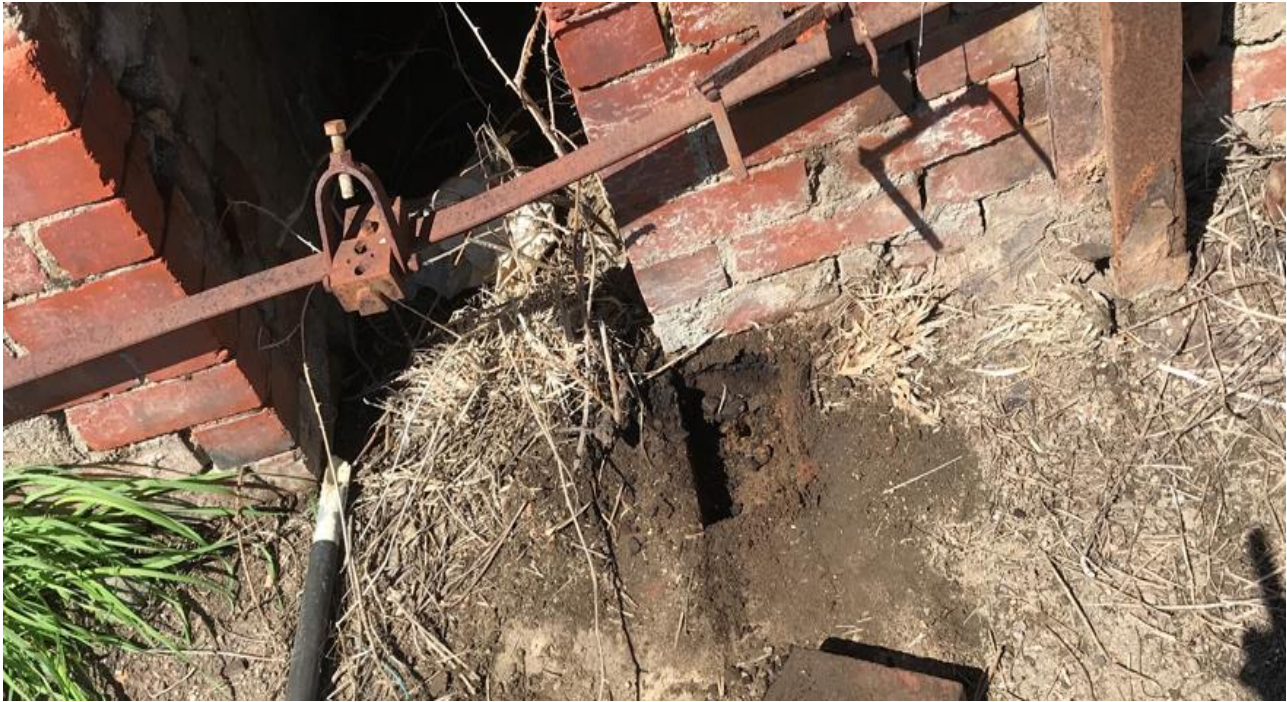
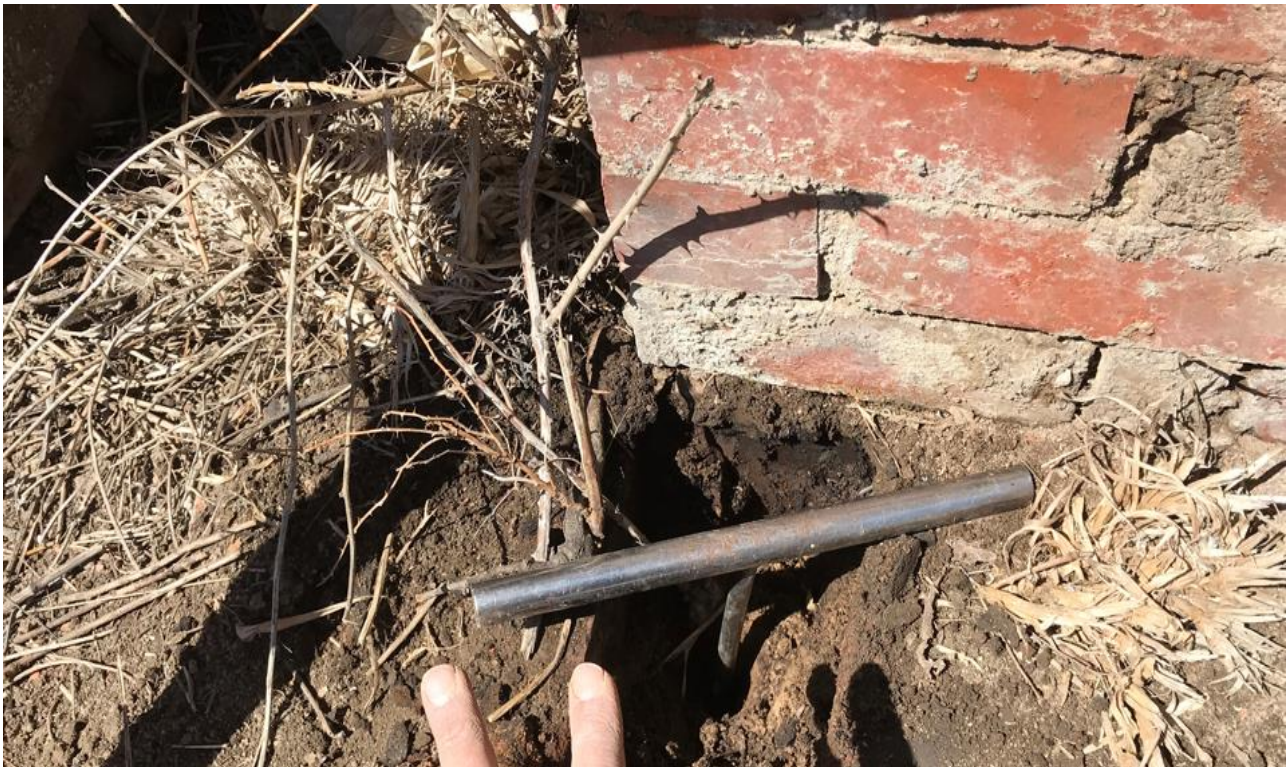
## Footing Probe 2

**FOOTING PROBE STOPPED DUE TO DEPTH  
FP BOTTOM NOT FOUND**
